# Making the Connection Between Low Budgets and Pavement Maintenance Needs for Small Regional Airports In Southern Africa

**Dr Emile Horak &  
Dr Stephen Emery**

KUBU Consultancy Pty Ltd

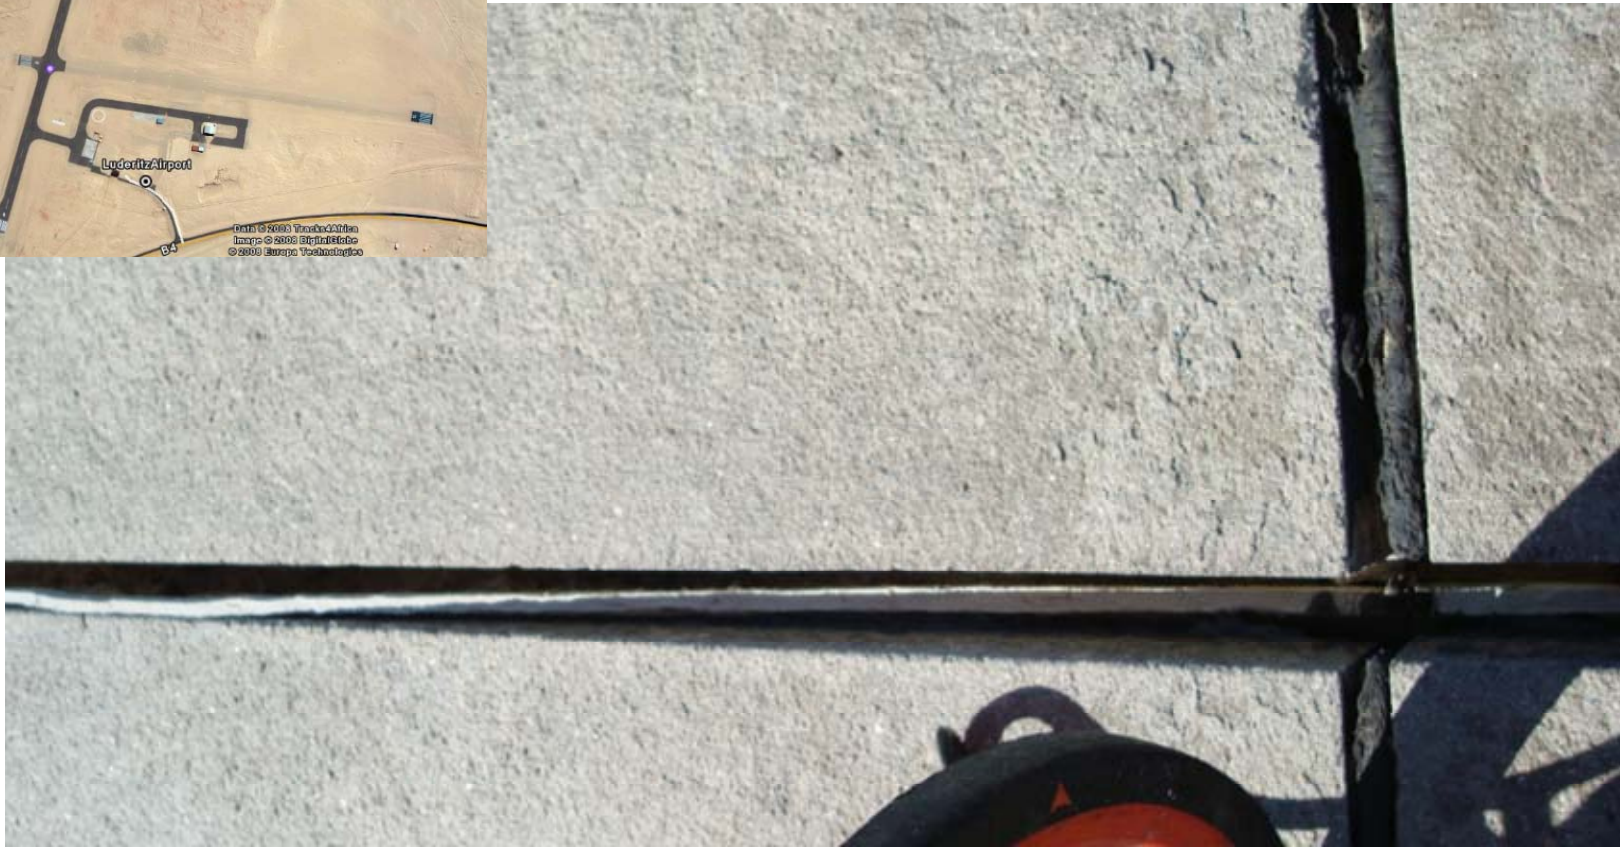
**LA 5: Localised construction joint at main runway 04 end in need of repair via crack filling.**

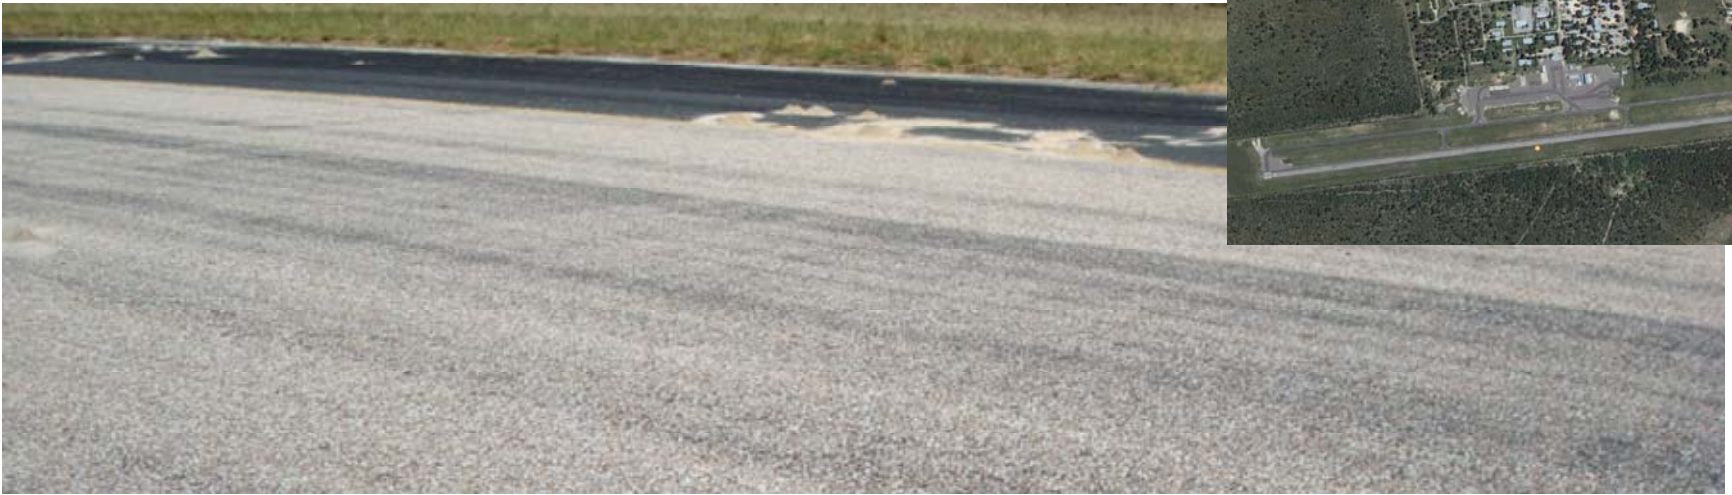
**KMA 8: Shoulder at the 27 end showing ant activity, vegetation intrusion, longitudinal cracking on the shoulder and extreme map cracking on the paved area. Faint and fading line marking are also shown.**

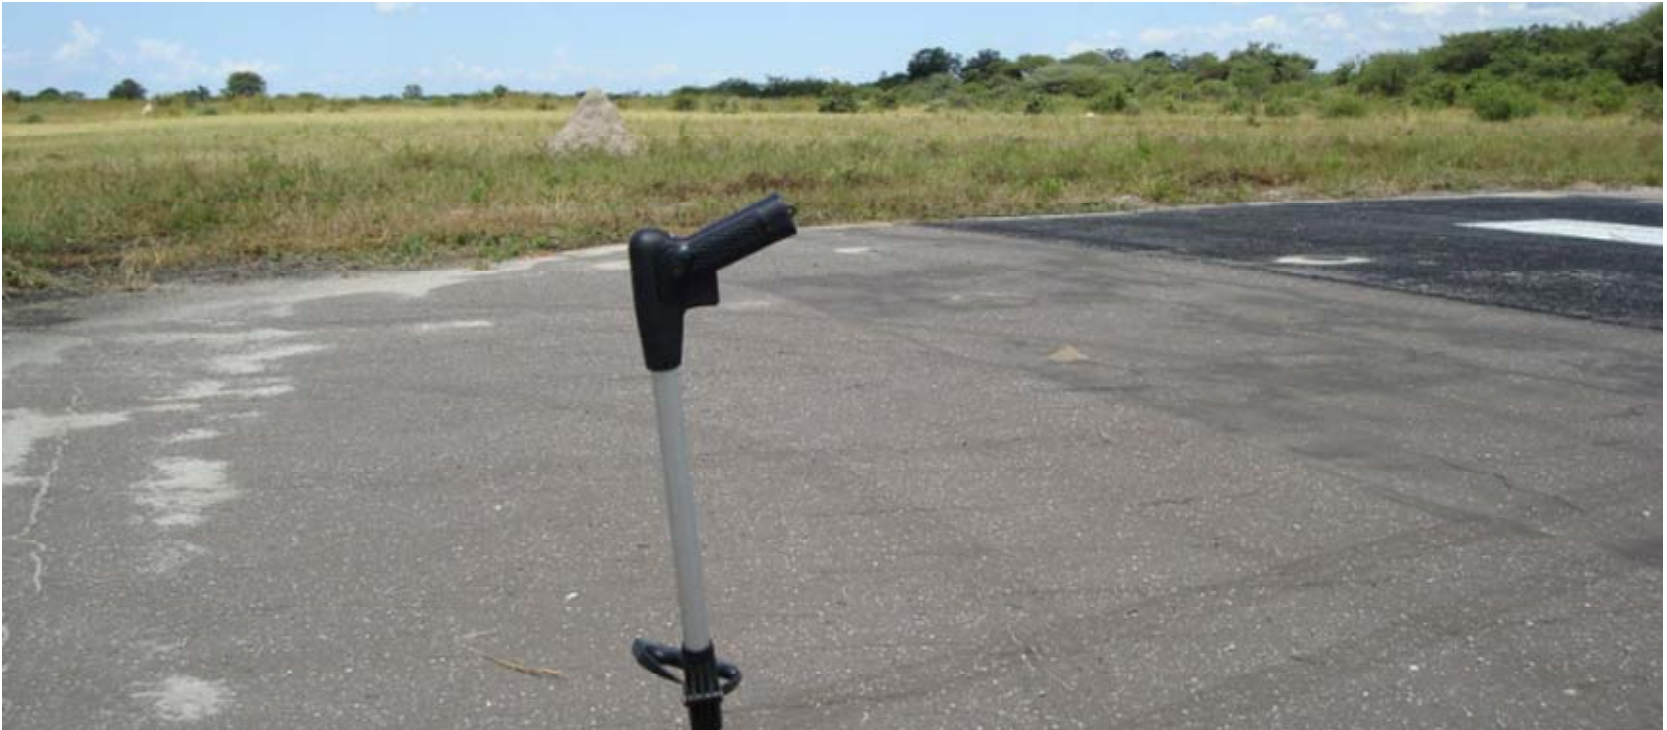
**KMA 11: extent of ant activity on paved shoulder area.**

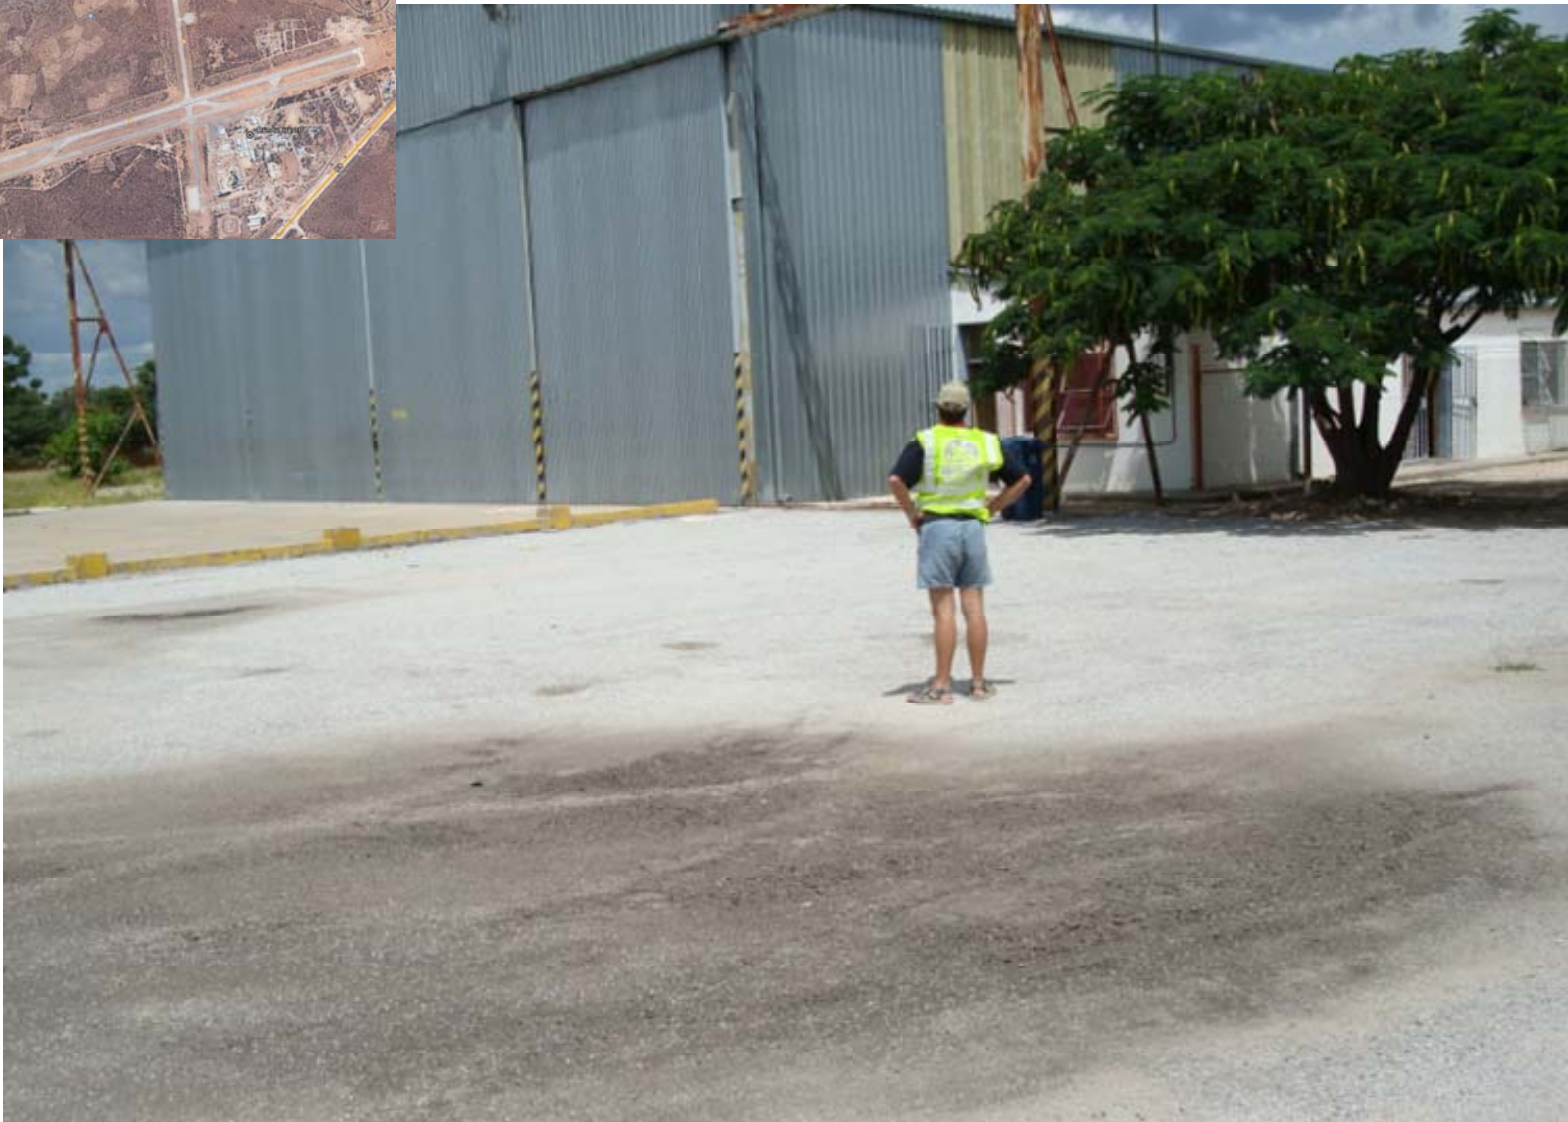
**RA 1: Apron area in front of terminal building and hangar. Evidence of ponding seen in the foreground. Area under tree to the right was flooded during the subsequent rain storm.**

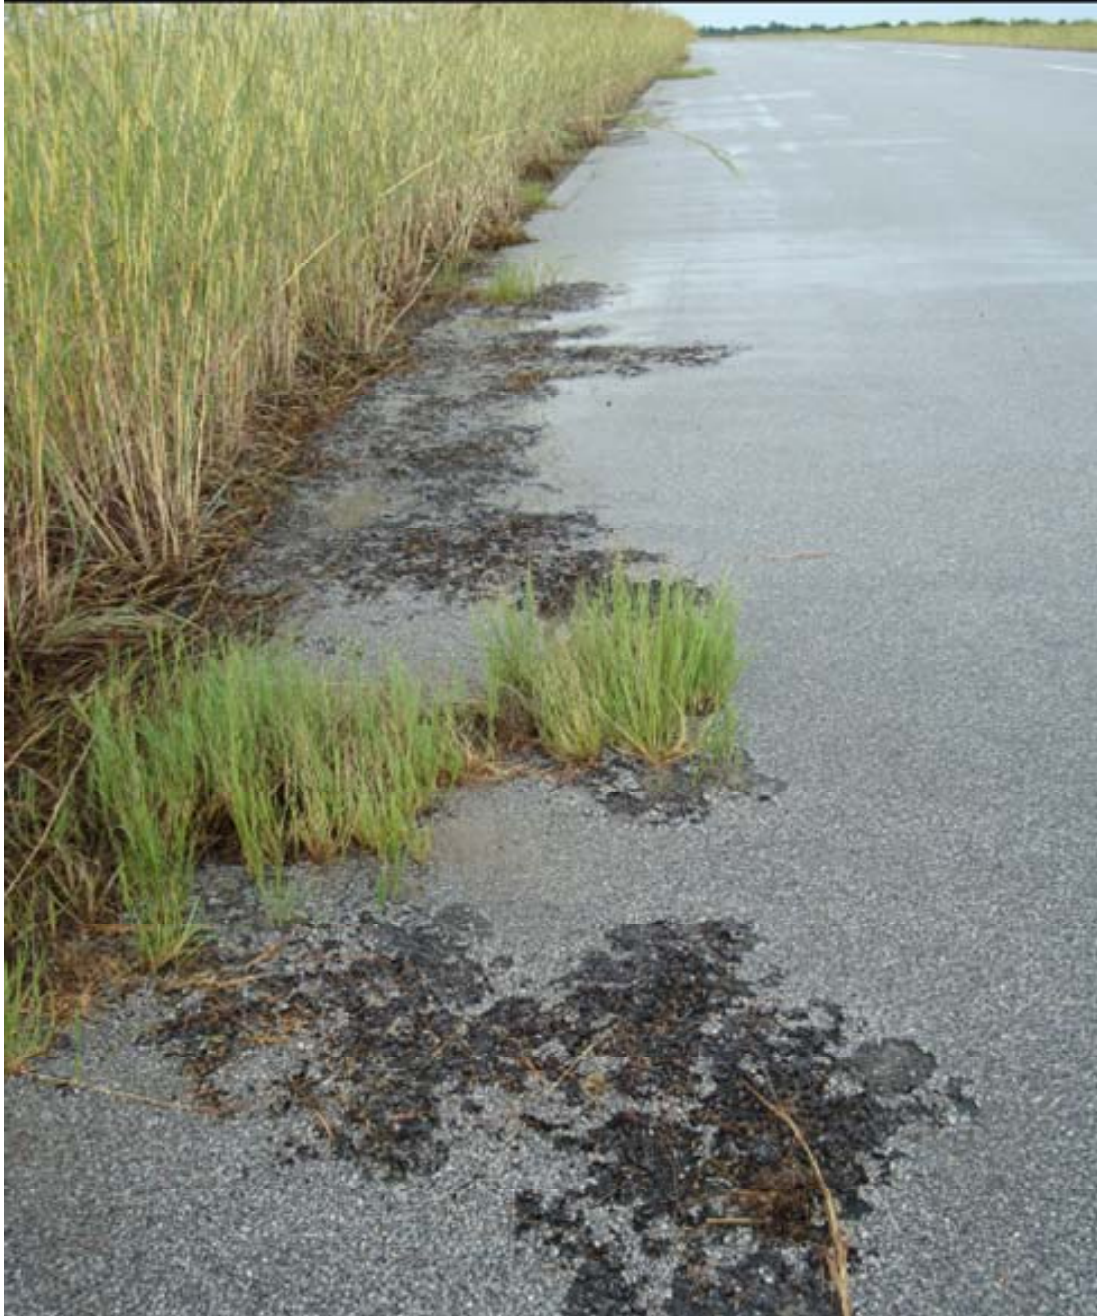
**RA 3: Intrusion and break up of shoulder asphalt area due to vegetation and high grass on shoulder blocking side drainage.**

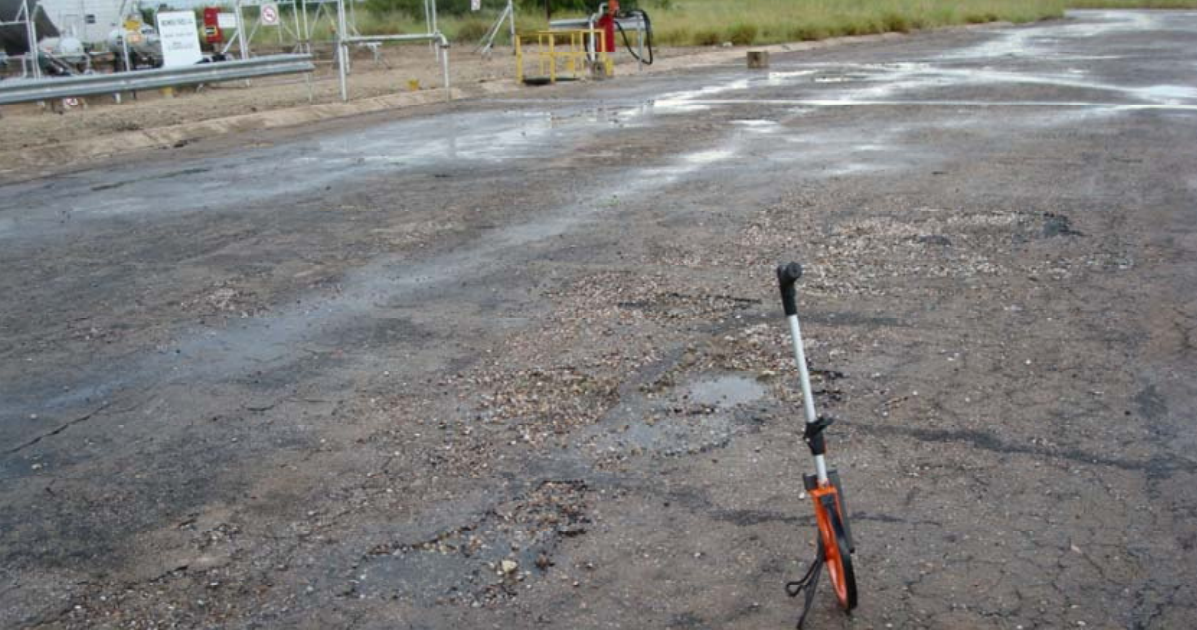
**RA 12: Potholes and loose gravel extent plus extreme cracking on refuelling apron area directly after rain storm.**

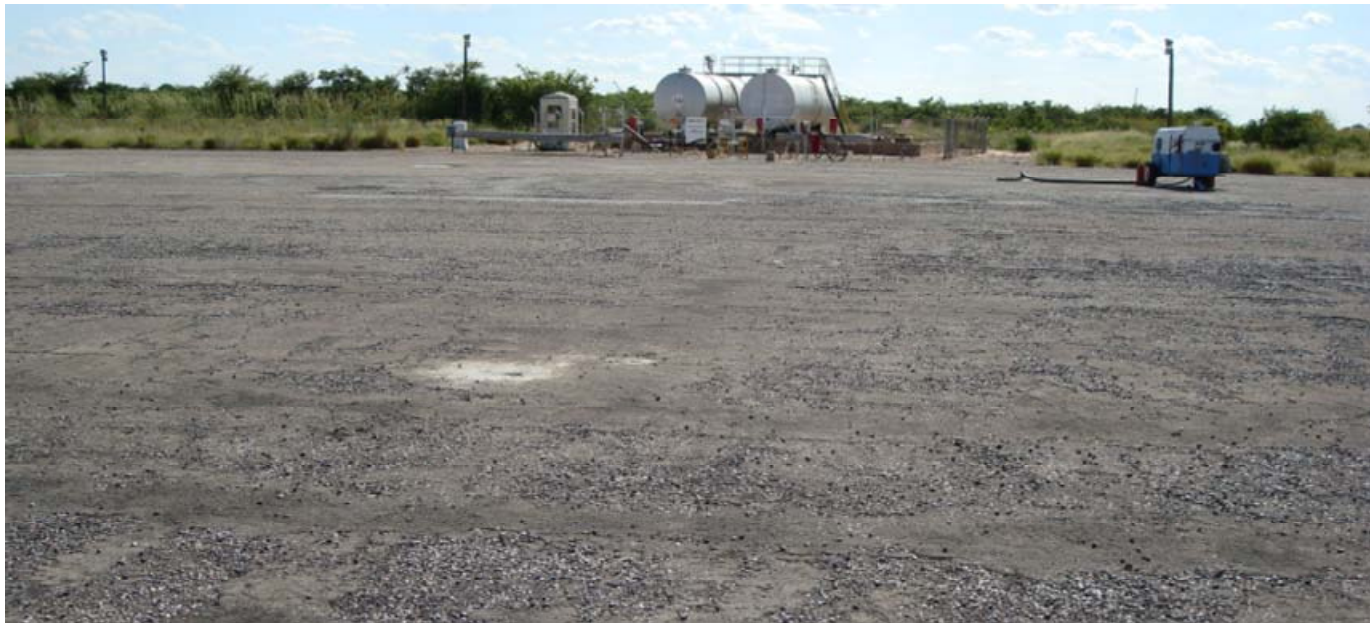
**RA 4: Badly distressed area in front of refuelling area. Area has loose stones and potholes everywhere and is a FOD hazard. Mobile fuel pump in right hand side.**

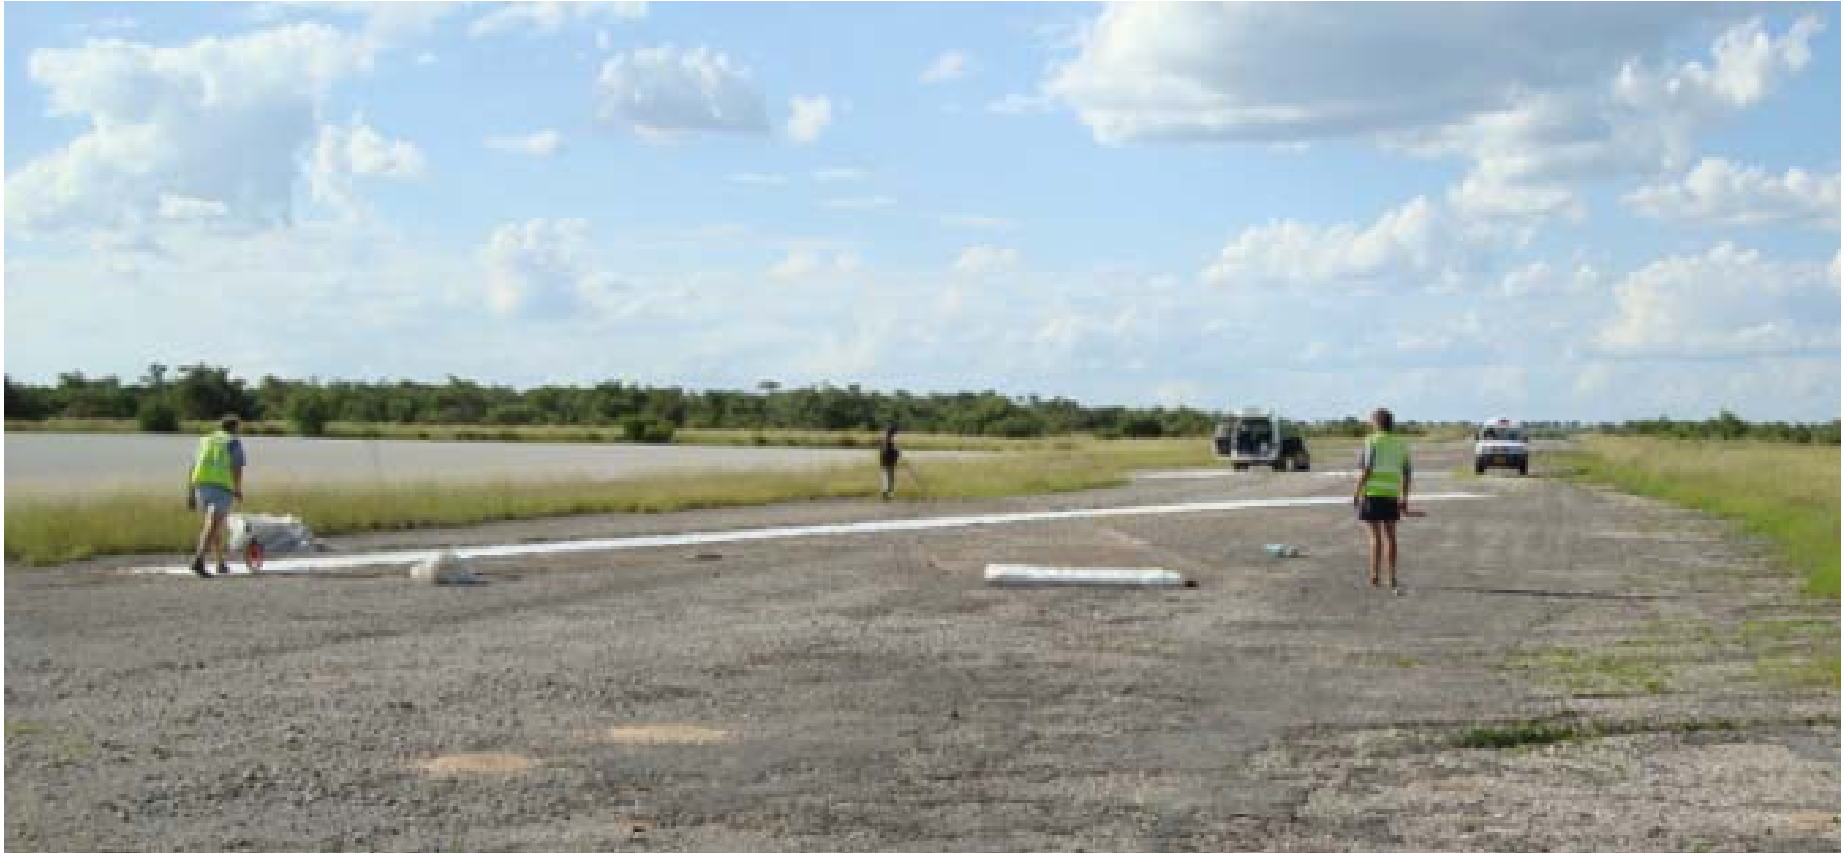
**RA 6: Set-out of closure marking on secondary runway end. Discarded paved parking area is seen on the left hand side.**

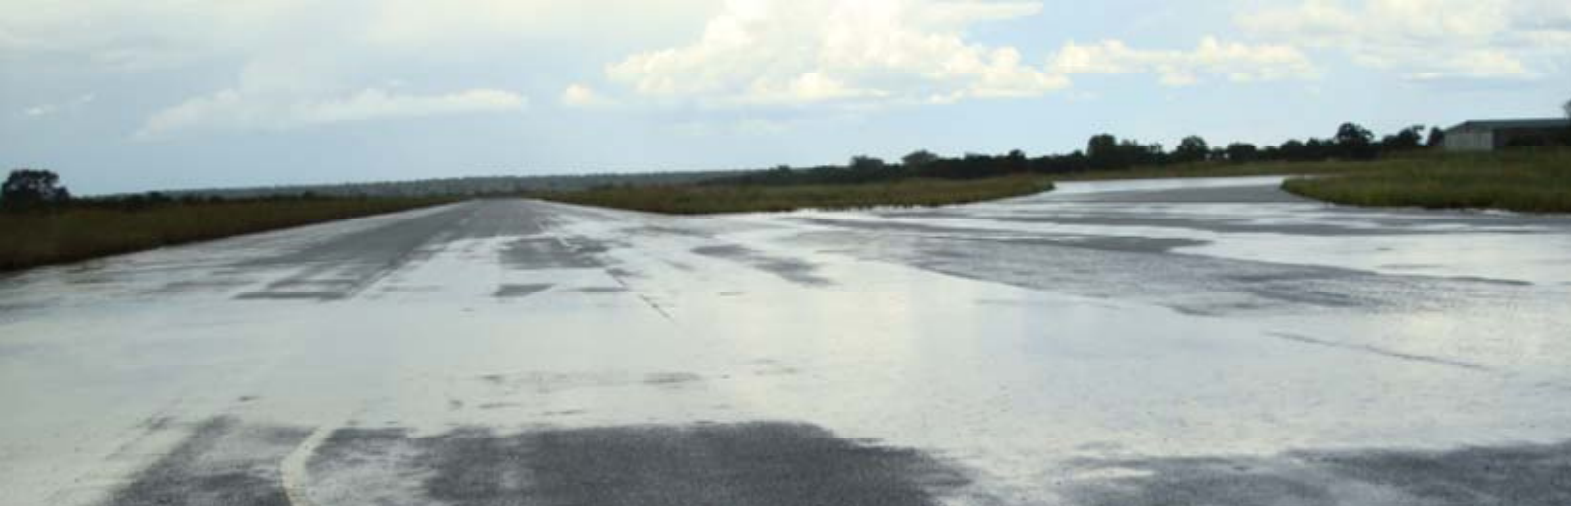
**Figure RA 7: Sheet flow over main runway at RET and secondary runway intersection.**

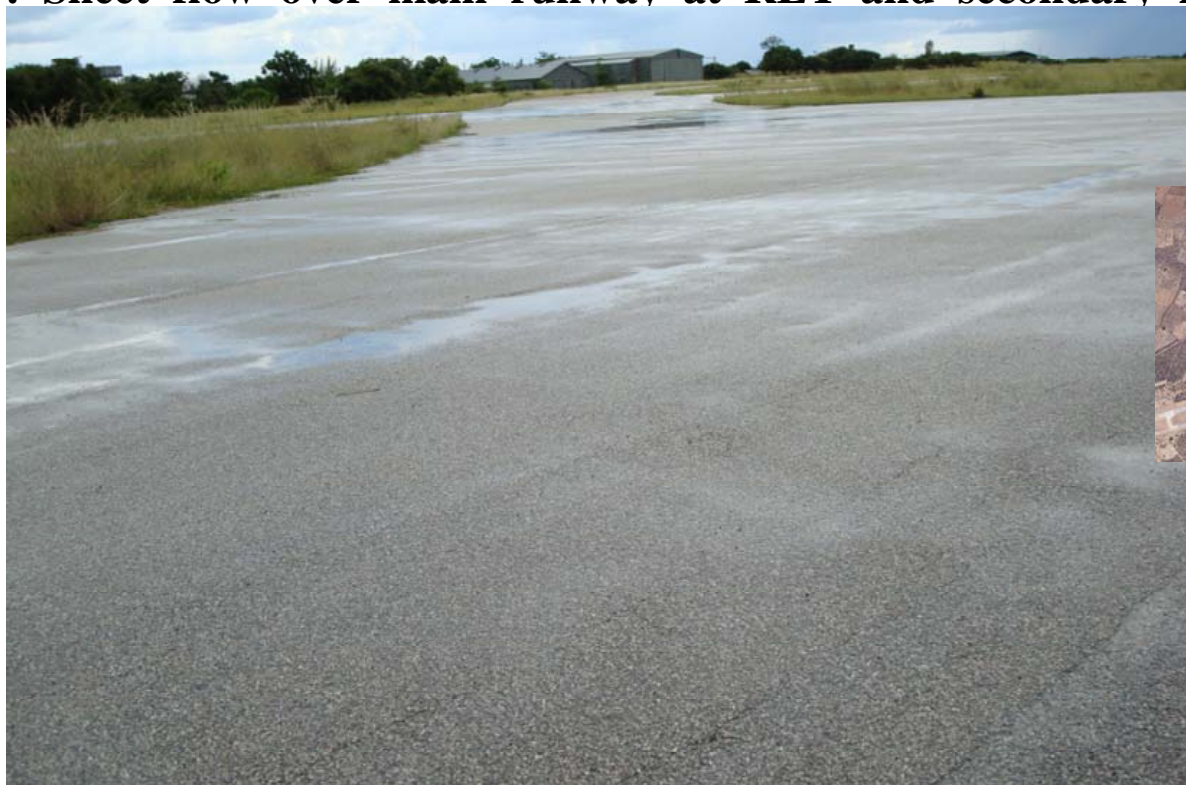
**RA 10: RET on 26 end showing some ponding and longitudinal cracks in the foreground on the main runway**

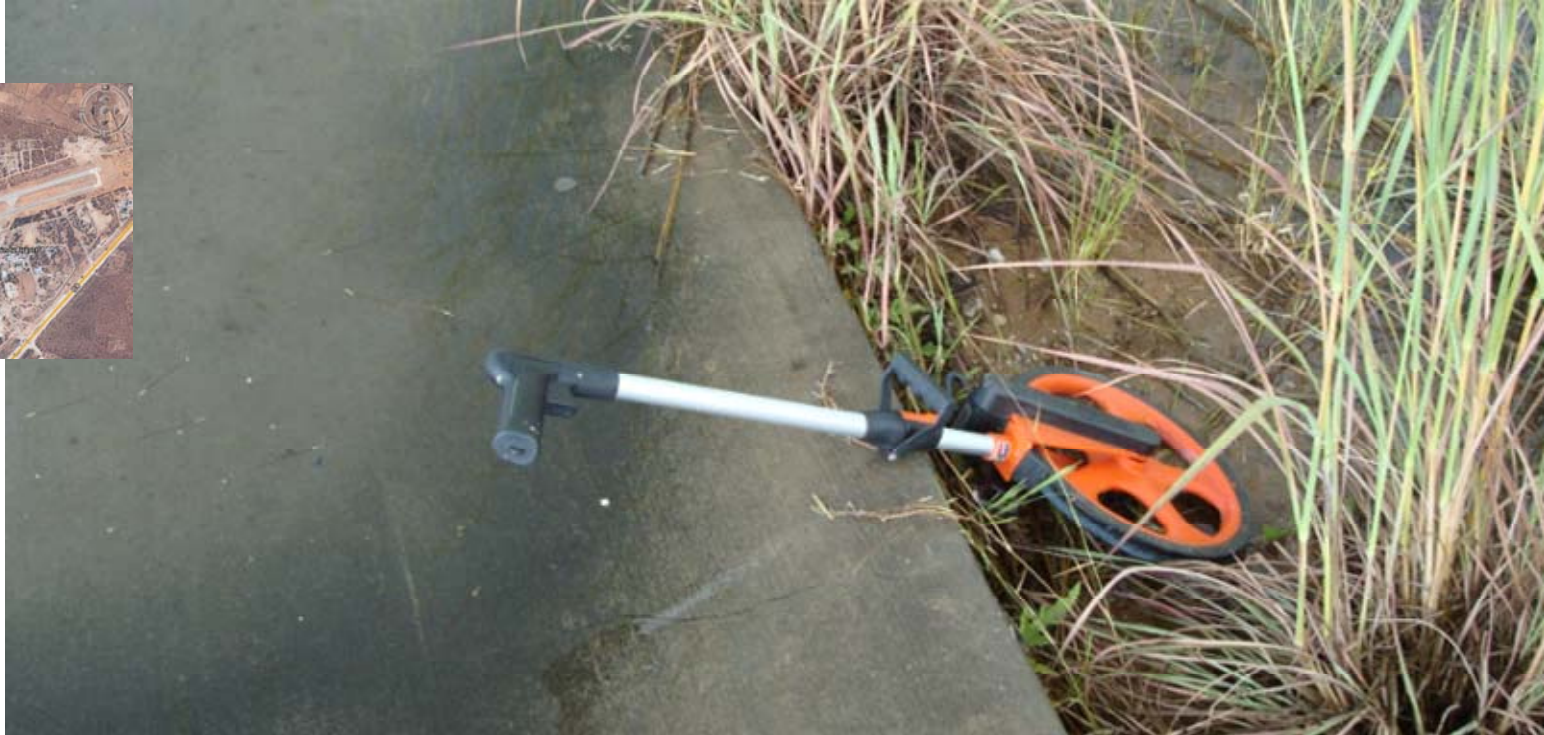
**RA 8: Extent of step at 26 end due to erosion as well as vegetation**

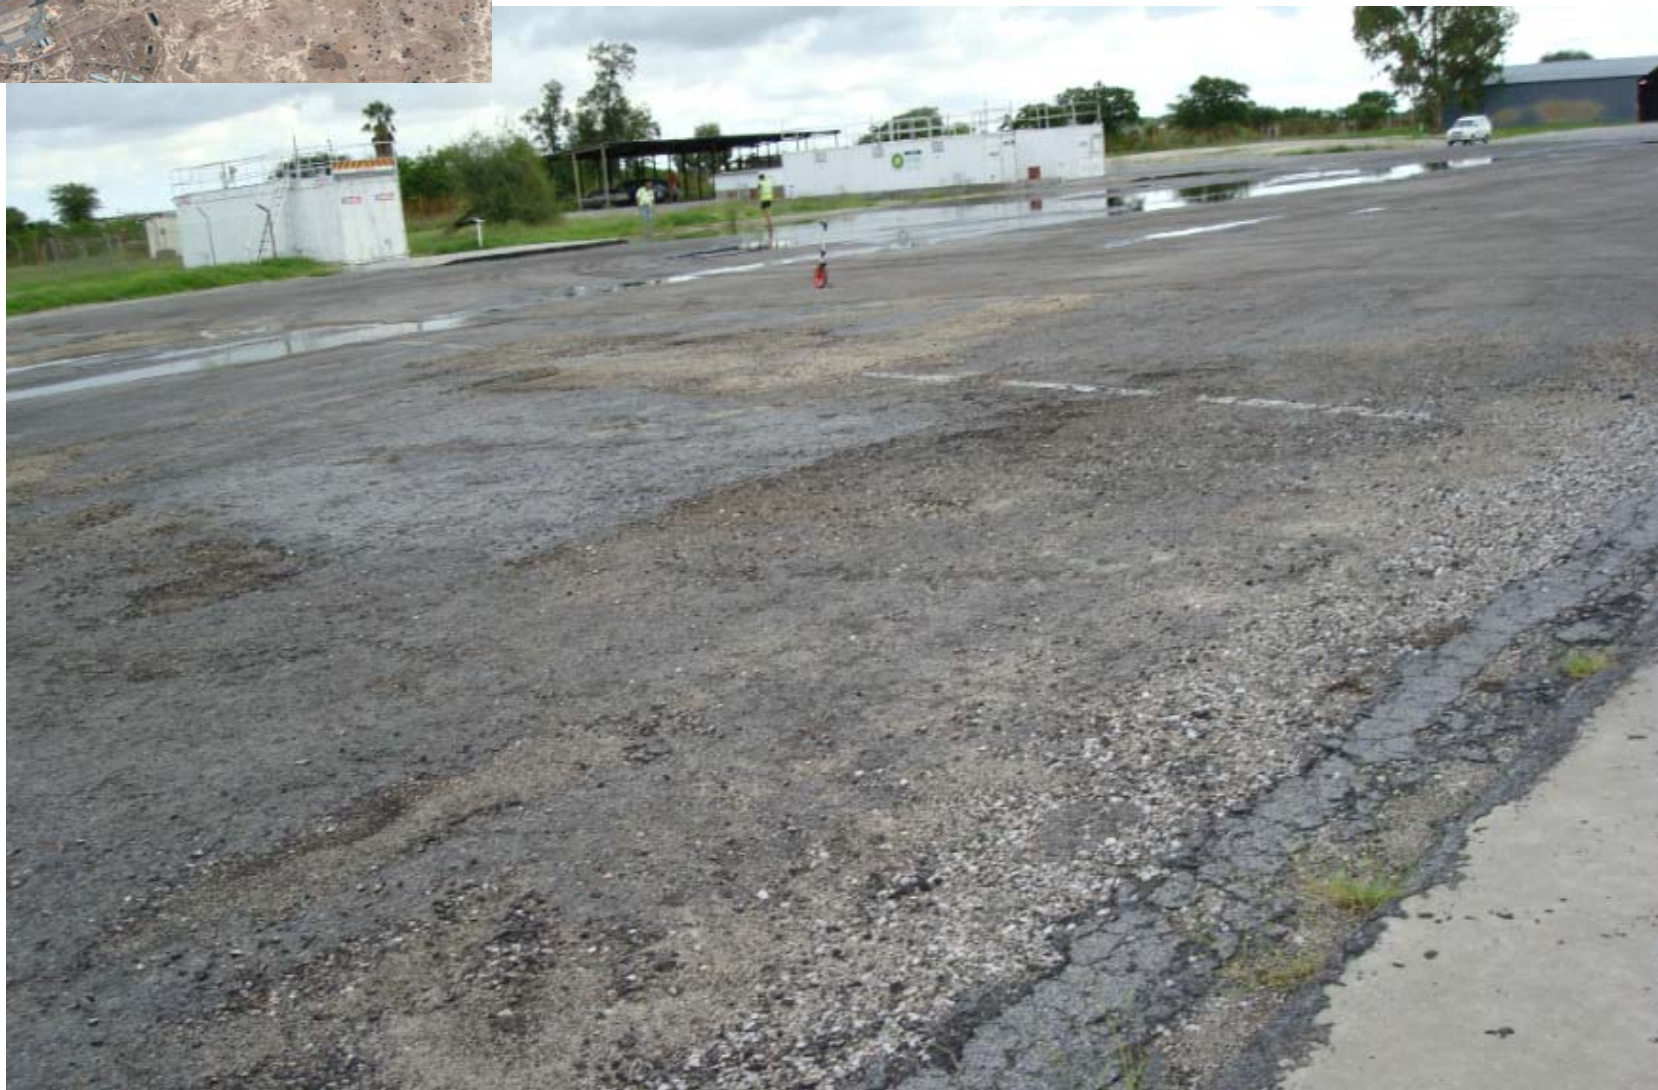
**OA 2: Extent of ponding in front of modular refuelling units on area B. Extent of aging , ravelling and cracking in the foreground.**

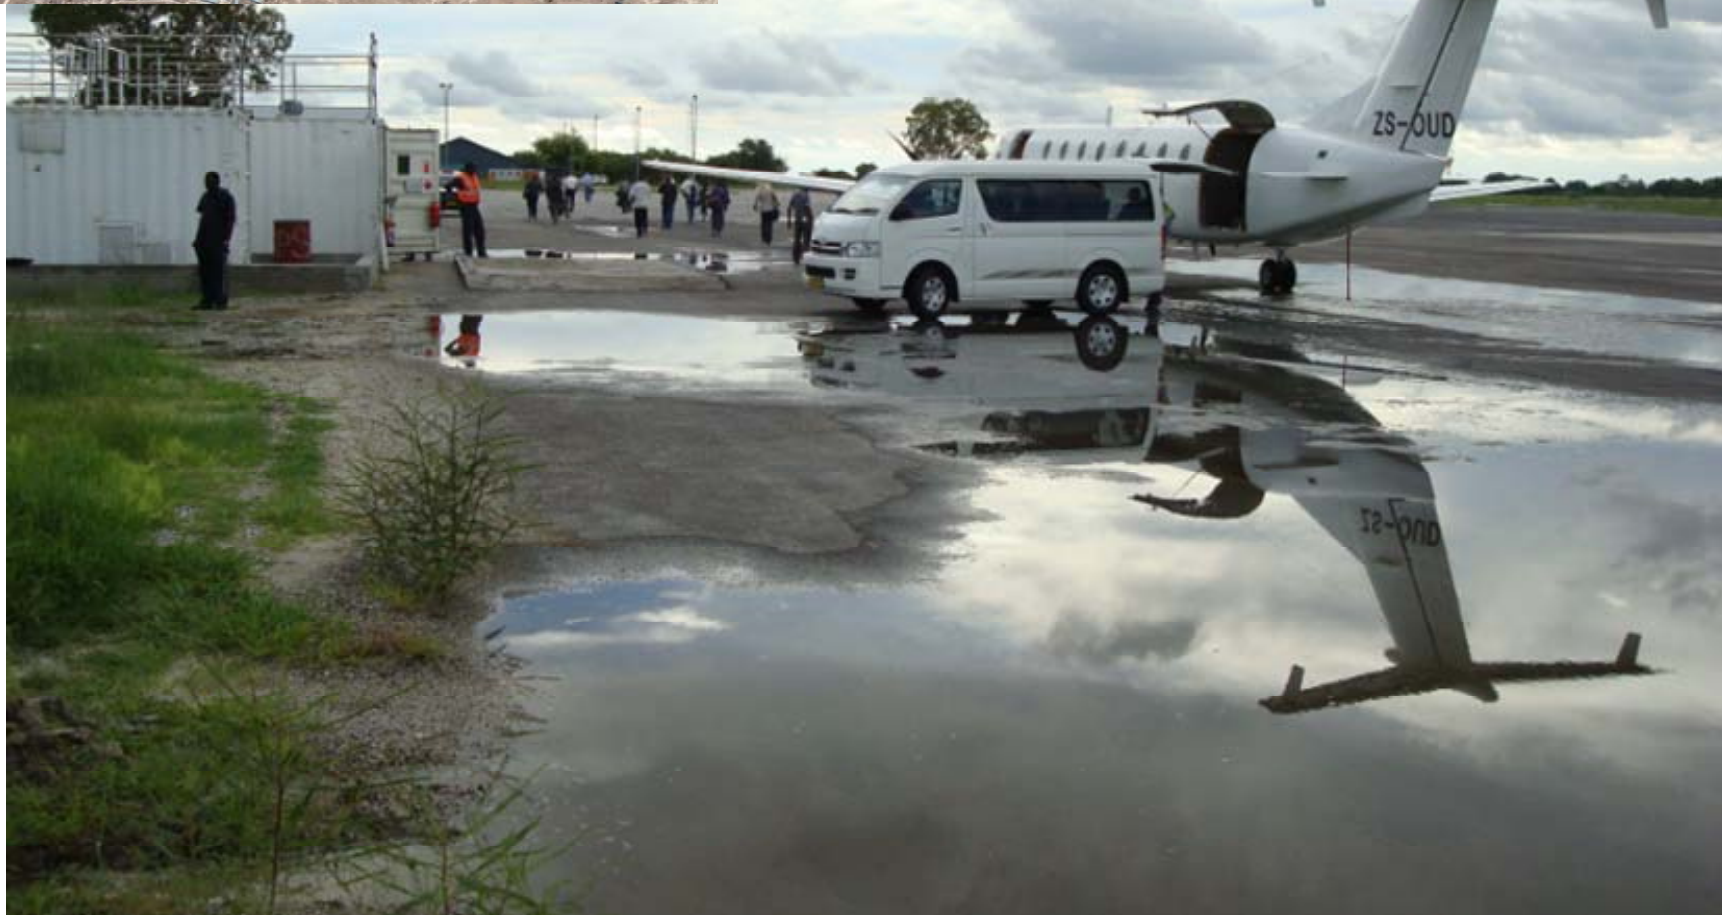
**OA 3: Aircraft parked in front of modular refuelling units in water pond. Passengers disembarking and walking towards passenger terminal directly ahead. Shallow trench dug in left corner managed to drain the ponding.**

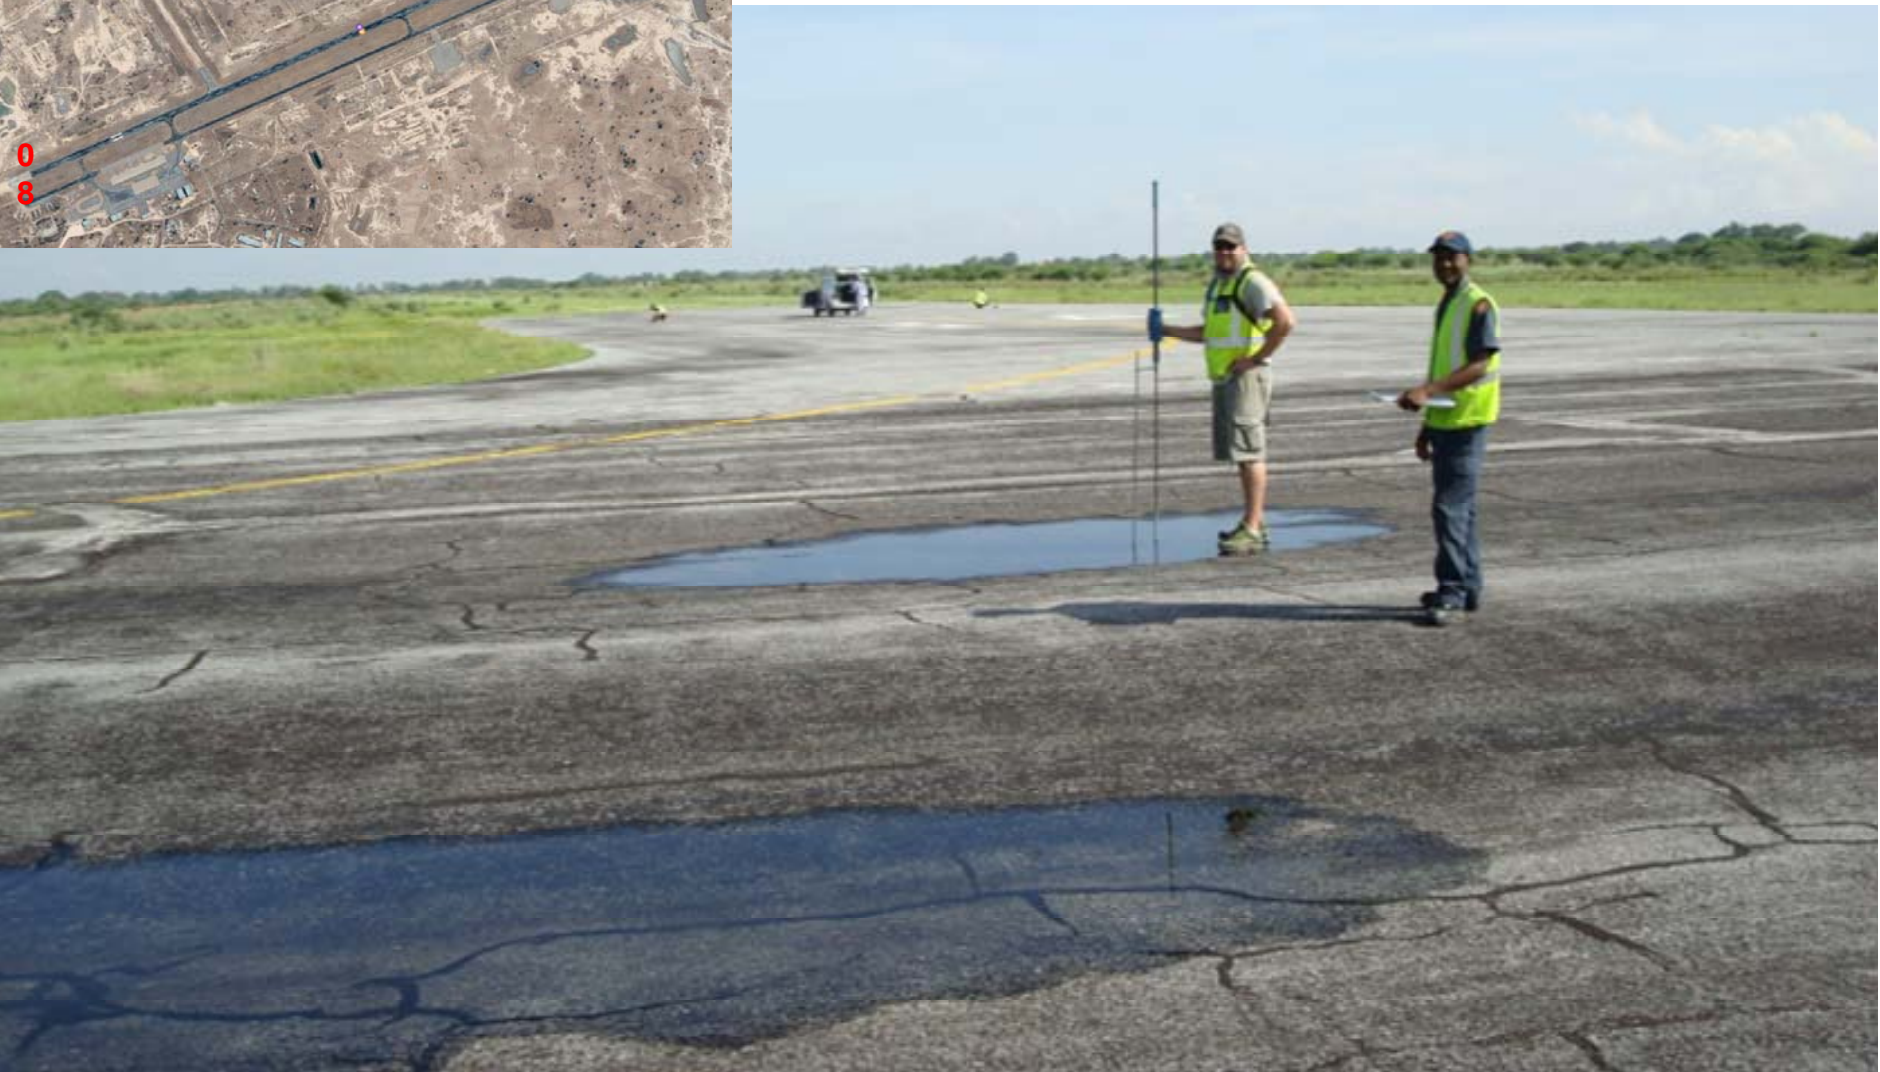
**OA 12: DCP sounding to be done in bird baths one day after the rain at intersection with secondary runway. In back ground set-out of closure cross on secondary runway in progress. Observe extent of crack sealing.**

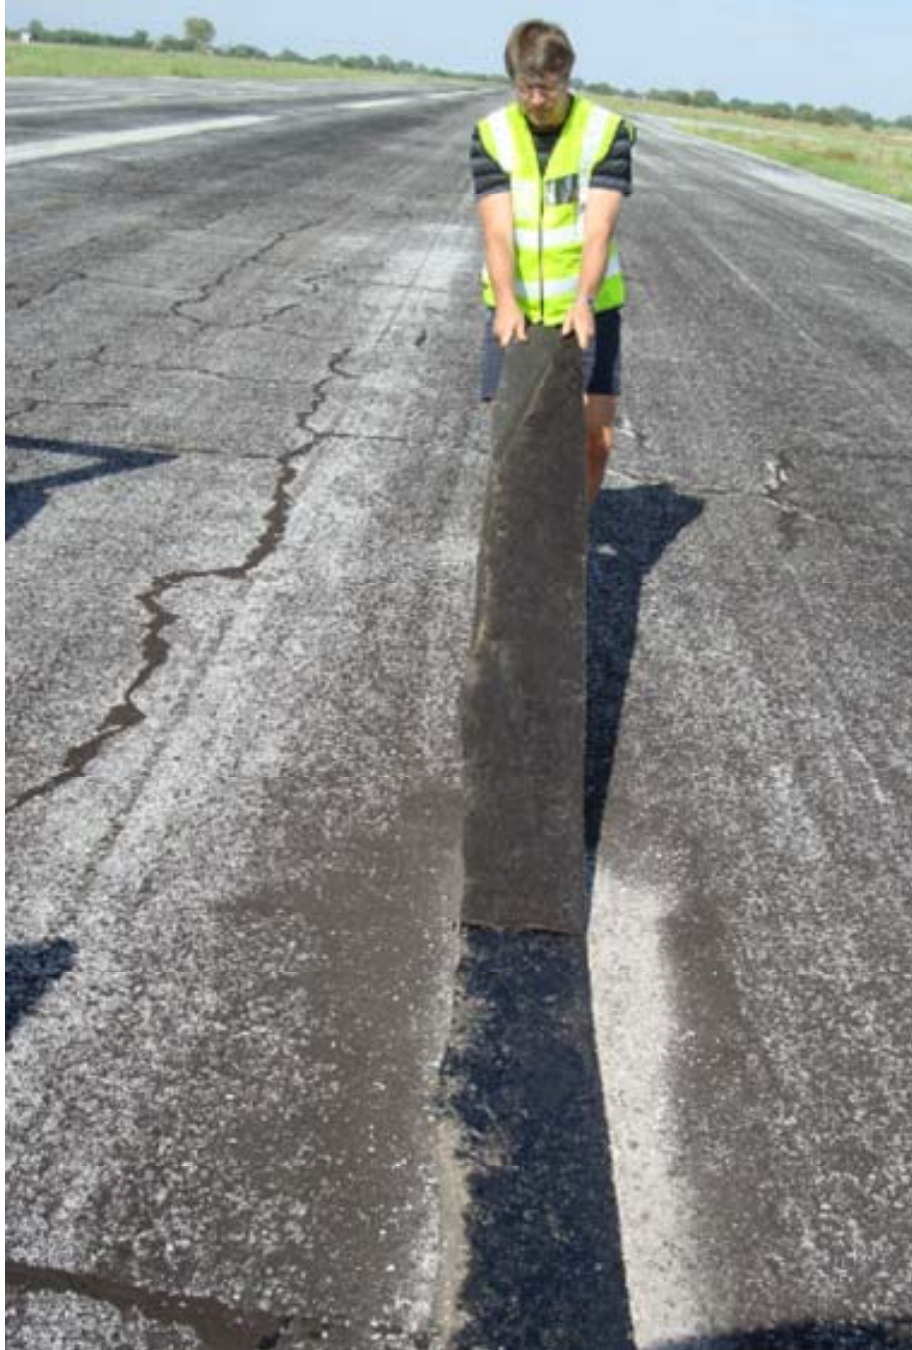
**OA 14: Loose geo-fabric at 2007 crack sealing on shoulder. Extent of previous crack sealing and aged surface can also be seen.**

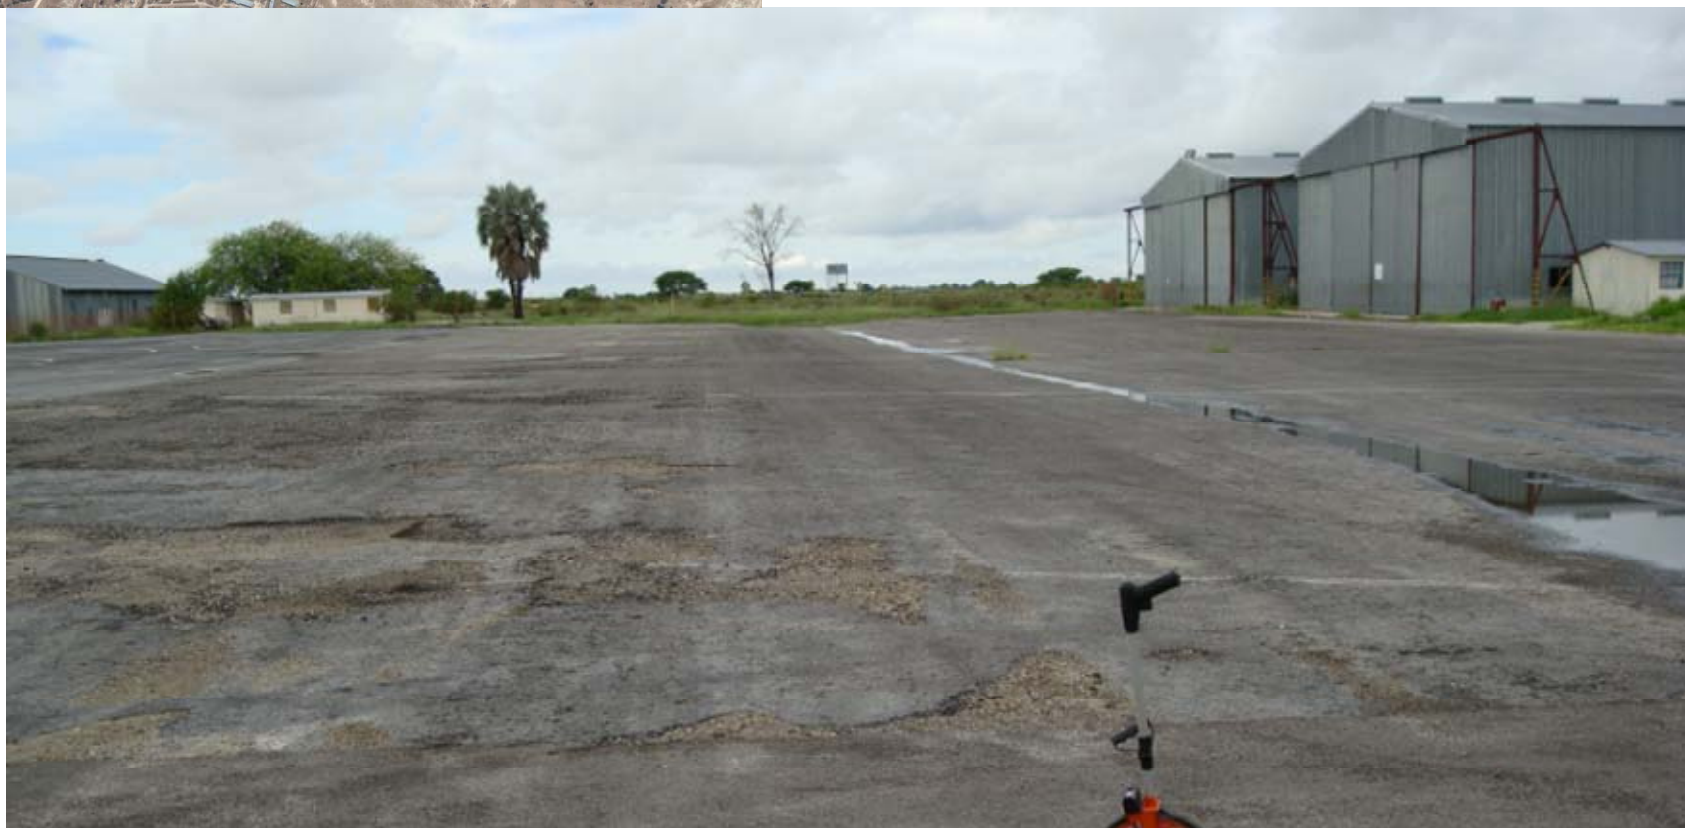
**OA 22: Badly potholed and ravelling area A linking newly constructed refuel apron with area in front of large hangers. V type drain functioning in foreground.**

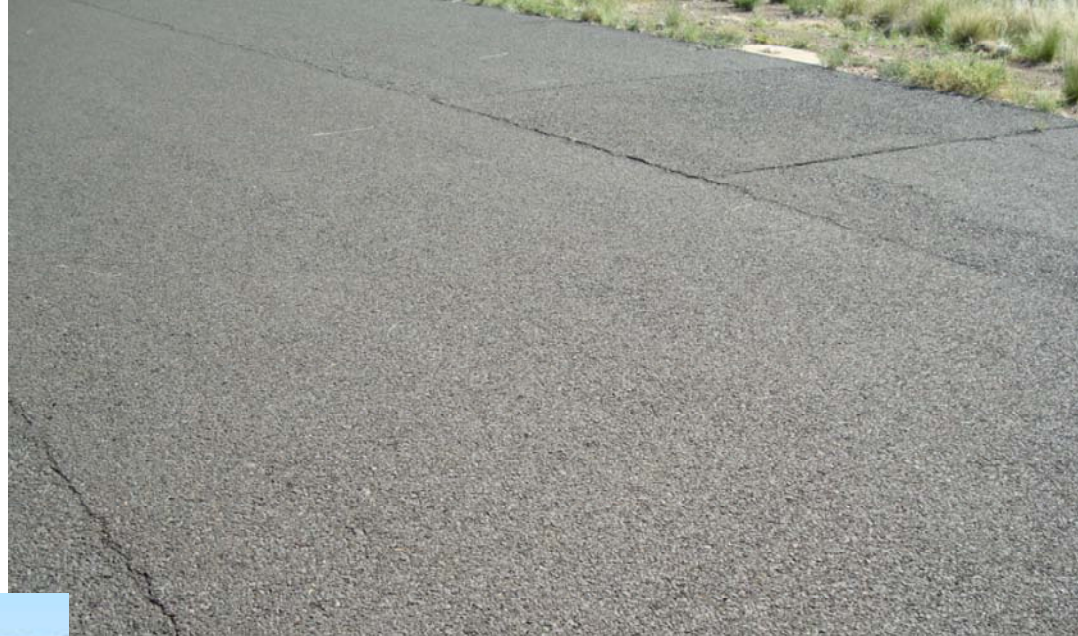
**3: Longitudinal cracking and localised repair on shoulder.**

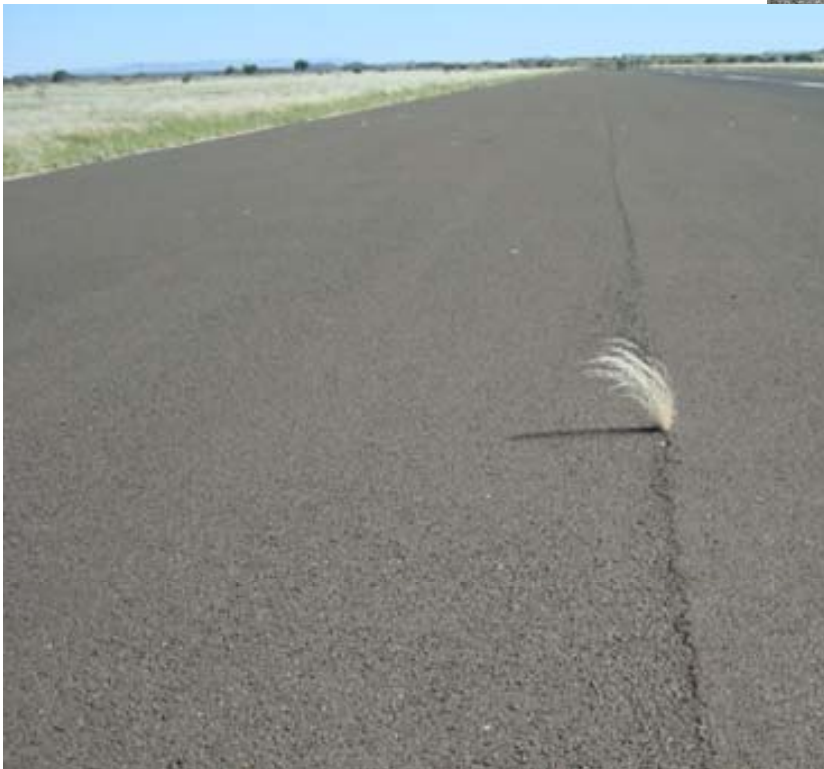
**KA 6: Longitudinal cracking with vegetation in old construction joint on shoulder of main runway.**
