# Making the Connection Between Low Budgets and Pavement Maintenance Needs for Small Regional Airports In Southern Africa

**Dr Emile Horak &  
Dr Stephen Emery**

KUBU Consultancy Pty Ltd

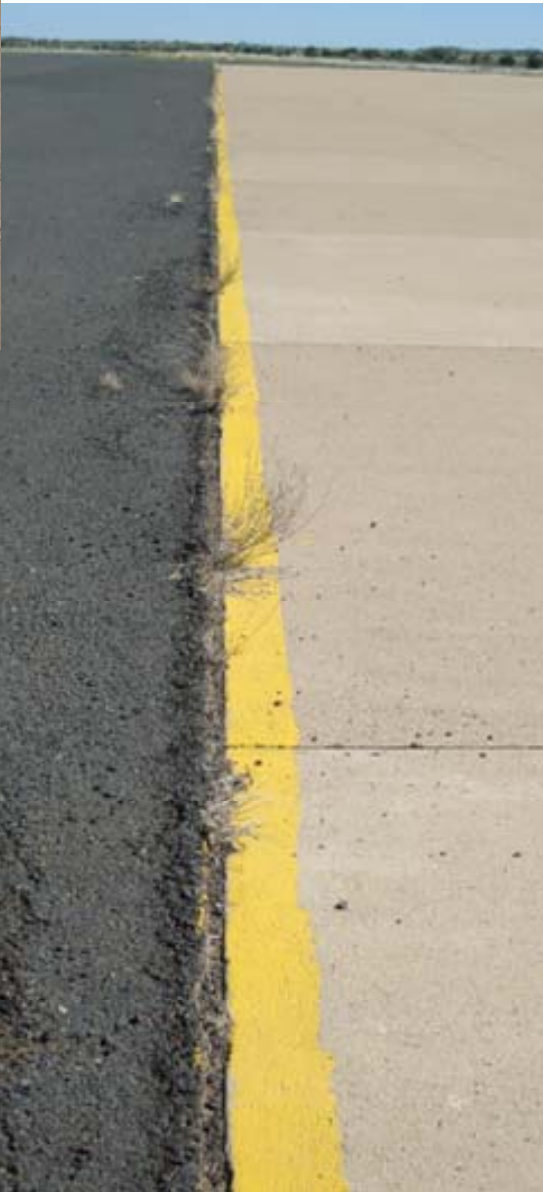
**KA 12: Evidence of shoving of concrete slabs on passenger apron. Vegetation growth in cracks.**

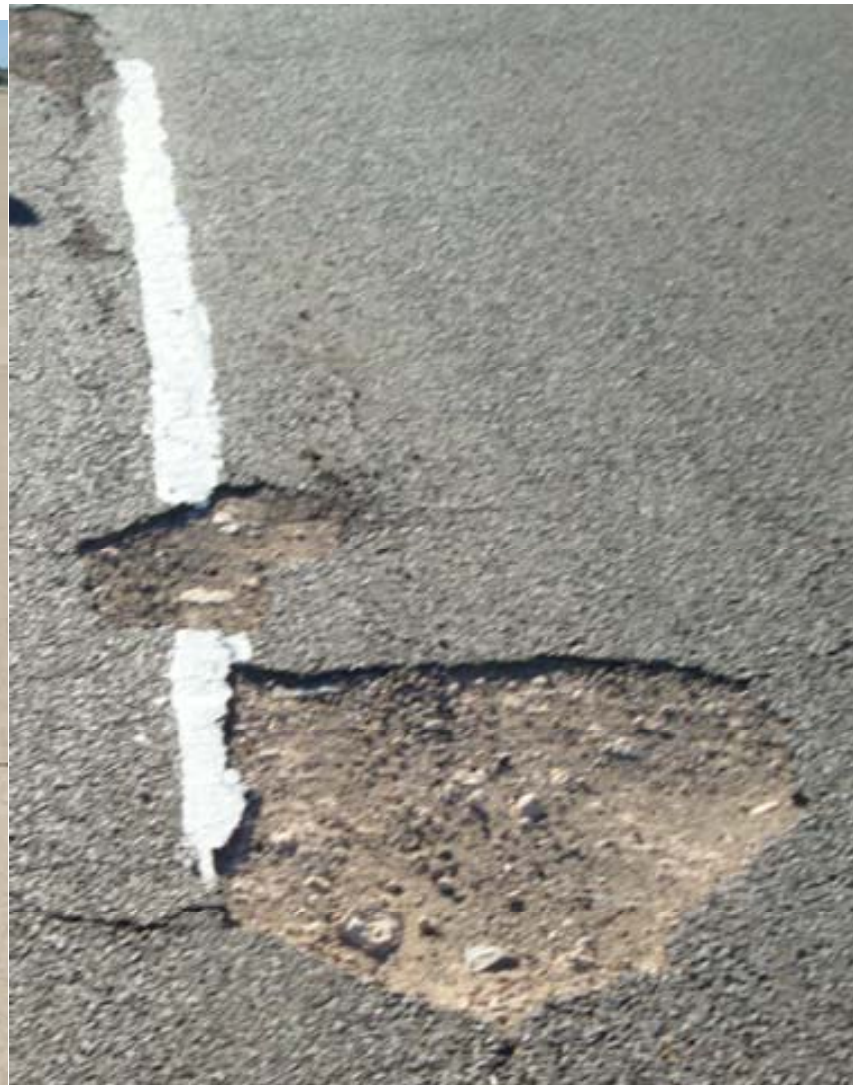
**KA 11: Localised pothole on secondary taxiway.**
