DETERMINING THE EFFECT OF SUPER FINE TILLITE FILLER IN AN ASPHALT LAYER

E HORAK* and S EMERY**

Abstract

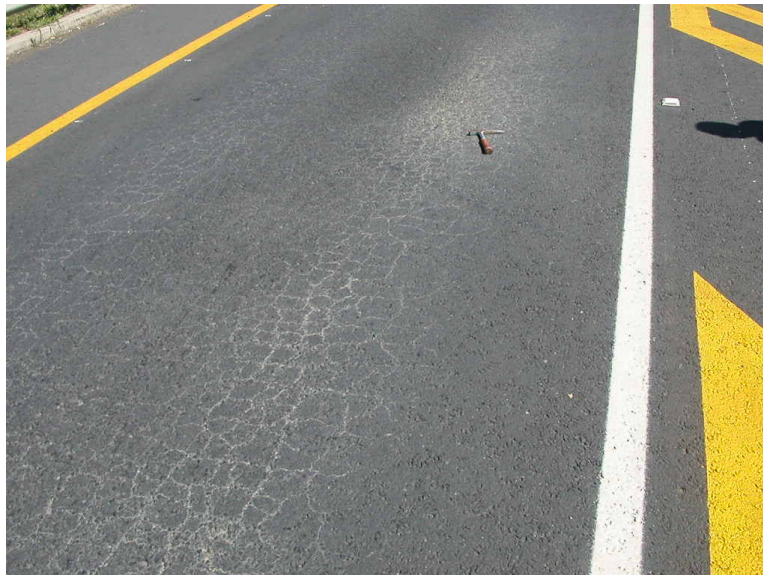
During the project construction period, limited areas of distress on the earliest sections were evident. The first visual surveys indicated that the surfacing showed signs of dryness, brittleness, and an increase in porosity and permeability. The extent of the area affected grew to cover most of the 22km length of the project. Over the following months, further deterioration occurred in the form of rolled-in chip loss, aggressive stripping of binder from surface stone, white fines pumping after rain, crocodile cracking and release of more white fines. The final stage of visually observed surface related deterioration appeared like crocodile cracking with obvious signs of water intrusion into the under laying base.

Image of typical early cracking, fines occurrence and crocodile type cracking on a section of the road (August 2003)

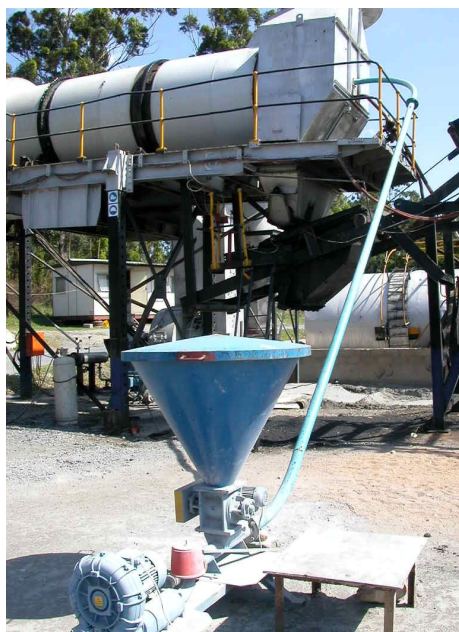
The drum mix asphalt plant was still operating when the investigation started.

Lime was initially added via the aggregate conveyor belt (probably during the trial mix laying). It was later added with a pump and pipe system. The plant had no baghouse fines filter system, but instead a cyclone dust collector system which sucked off dust and air right at the point where the feed-in pipe for the lime addition was positioned as can be seen clearly in the photo alongside.

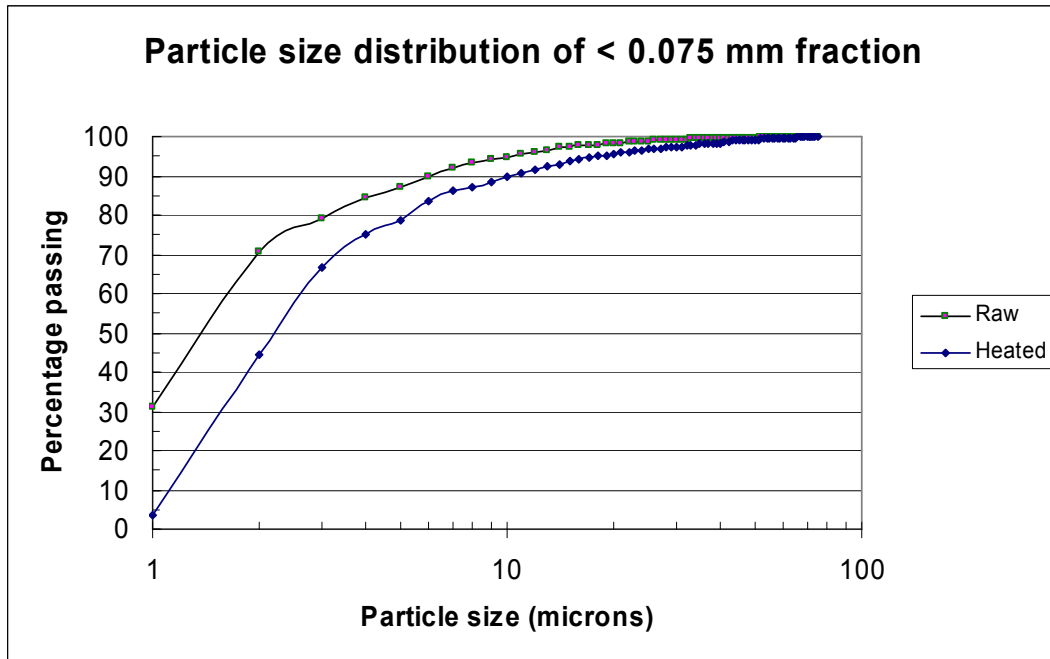
Figure 1. Grading of the tillite filler material.

A series of additional tests on tillite samples from the quarry were done by the CSIR laboratories. These tests involved a modified Texas Ball Mill test series, where steel balls, water and heating of the sample were varied. It also involved water absorption tests and sand equivalent tests (standard and extended). These tests showed no unusual results and are not discussed here. However, the grading of the tillite filler portion produced by laboratory crushing (heated and raw) showed an extremely fine gradation determined by laser technology. Up to 90% were less than a diameter of 10 micron in both the raw and heated condition (i.e. were in the super fines size range). The grading of this material thus produced is shown in Figure 1 to follow. This super fine fraction reflected that the geological origin of tillite was fine rock flour and indicated the potential for producing super fines in asphalt during the abrasion action of mixing.

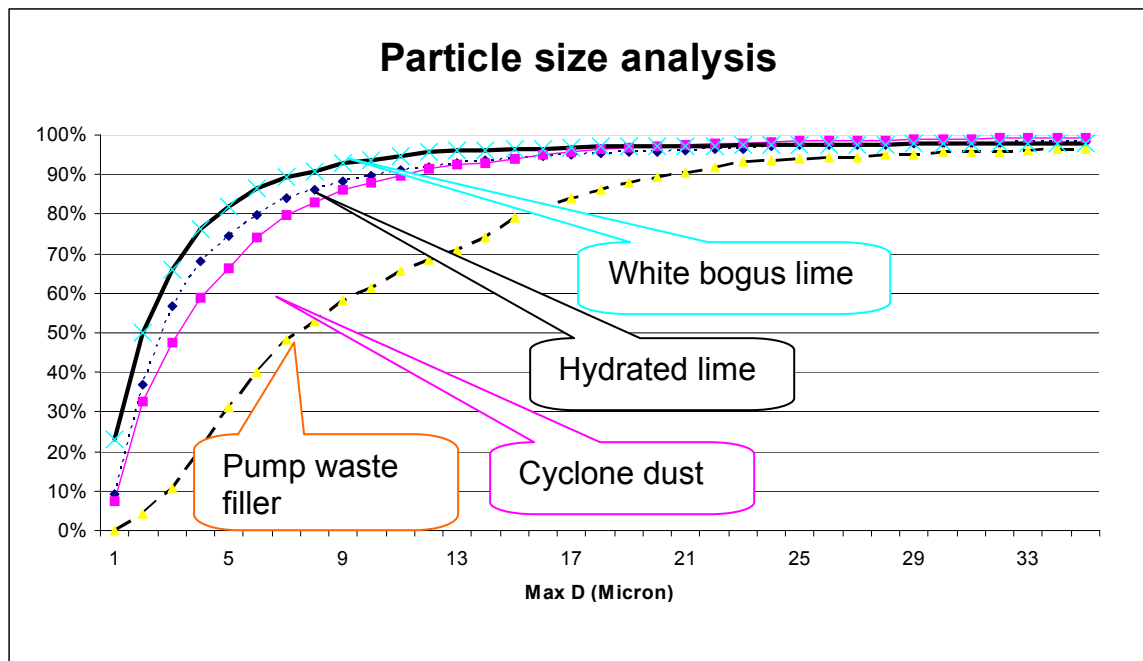
Figure 3. Filler material sampled particle size analysis

Particle size distribution was done with laser equipment at the CSIR on all these samples of filler sized material. In Figure 3 the grading analysis is shown for all the filler sized material sampled. A number of observations can be made:

- All the filler material was extremely fine as more than 90% of the lime, cyclone dust filler and "bogus lime" passed the 10micrometer size. More than 90% of the pump waste fines passed the 20micrometer size.
- The hydrated lime, cyclone dust filler and "bogus lime" had very similar gradings with only the pump waste filler showing a discernable difference.
- All these sampled filler sized material had gradings similar to the tillite filler material as reported in the geological investigation. This was circumstantial evidence that considerable amounts of the excess filler present in the mix could have been tillite.

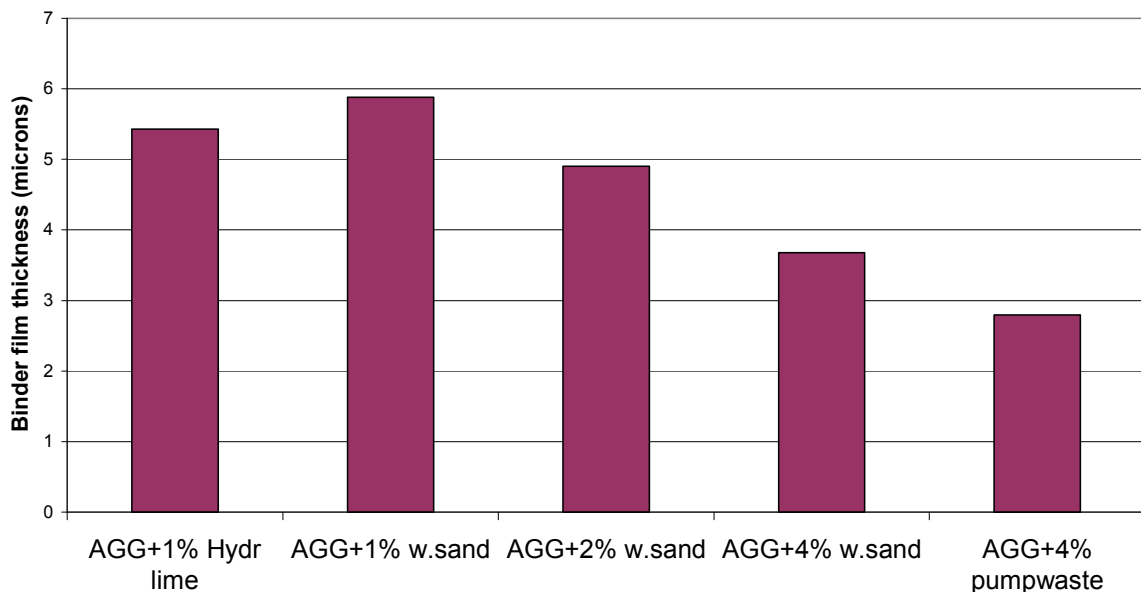
Figure 4. Binder film thickness with various additions of super fines

The effect of additional filler on binder film thickness was then calculated for varying percentages of added lime or filler. The calculation of aggregate film thickness is approximate because of differences in aggregate shape and texture. One well-known approximate method is that of Hveem (TRH 8, 1987). This uses the percentage aggregate passing various sieves from 4.75mm to 0.075mm in the calculation based on empirical factors. In this case the design grading was varied by adding various percentages of the “bogus lime” to the mix [this “bogus lime” is termed w.sand in Figure 4].

The effect on the resultant calculated binder film thicknesses are shown in Figure 4. It is evident that by adding increasing amounts of filler (super-fines) it significantly decreases the binder film thickness of the asphalt.

Effect of additional filler on binder film thickness

For the asphalt mix under investigation such excessive super fines present in the mix would have lead to a significant reduction in durability, especially as the film thickness dropped below the 5 micron level. It is clear that if, as suspected, the filler material was more or less doubled, it would have resulted in a dry and abrasive mix with construction problems. Again it provides an
