# Making the Connection Between Low Budgets and Pavement Maintenance Needs for Small Regional Airports In Southern Africa

**Dr Emile Horak &  
Dr Stephen Emery**

KUBU Consultancy Pty Ltd

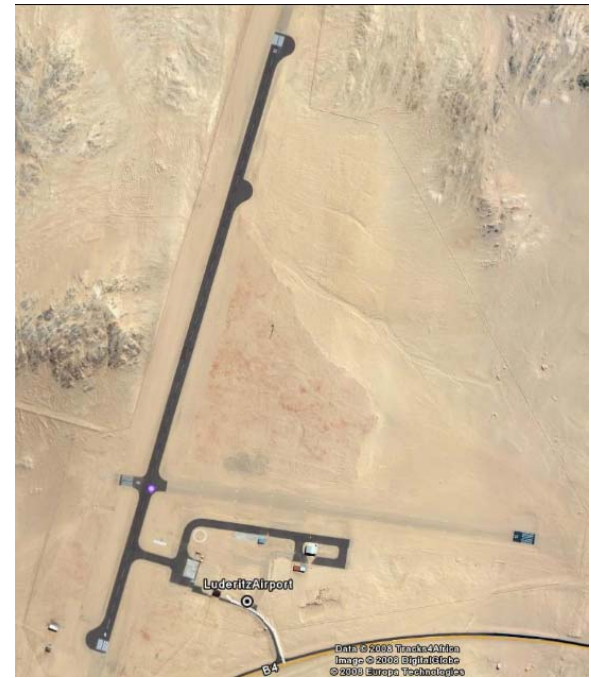
**LA 5: Localised construction joint at main runway 04 end in need of repair via crack filling.**

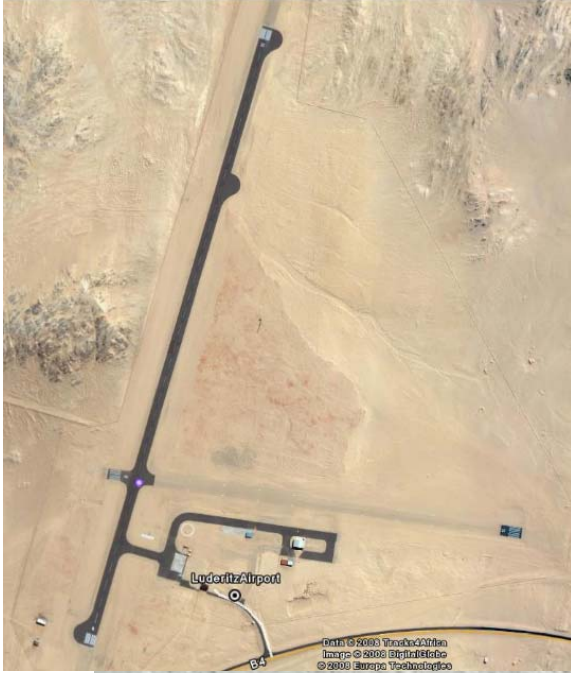
**LA 7: Joint opening up due to movement of slab on passenger apron.**

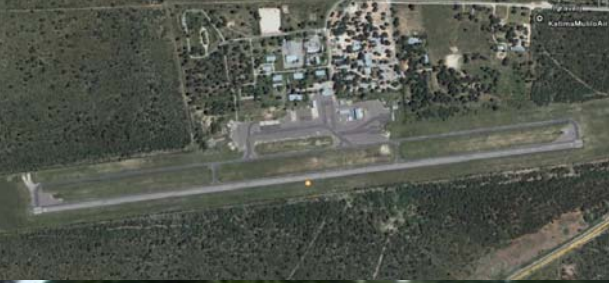
**KMA 3: Cracked and potholed area at refuelling apron next to small concrete apron area in foreground.**

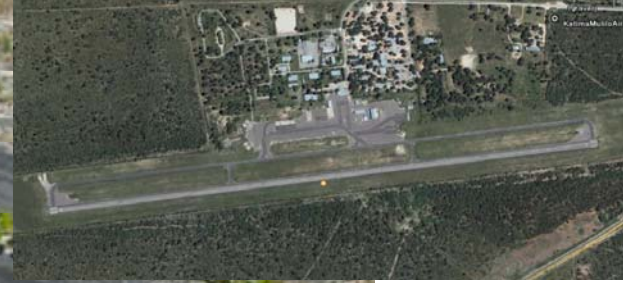
**KMA 8: Shoulder at the 27 end showing ant activity, vegetation intrusion, longitudinal cracking on the shoulder and extreme map cracking on the paved area. Faint and fading line marking are also shown.**

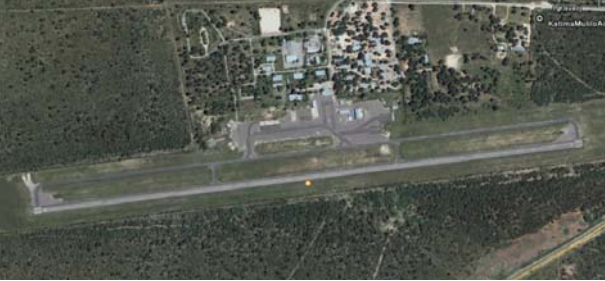
Apron and taxiway area sketch of Katima Mulilo airport

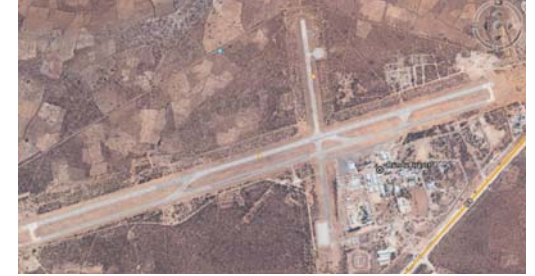
**RA 3: Intrusion and break up of shoulder asphalt area due to vegetation and high grass on shoulder blocking side drainage.**

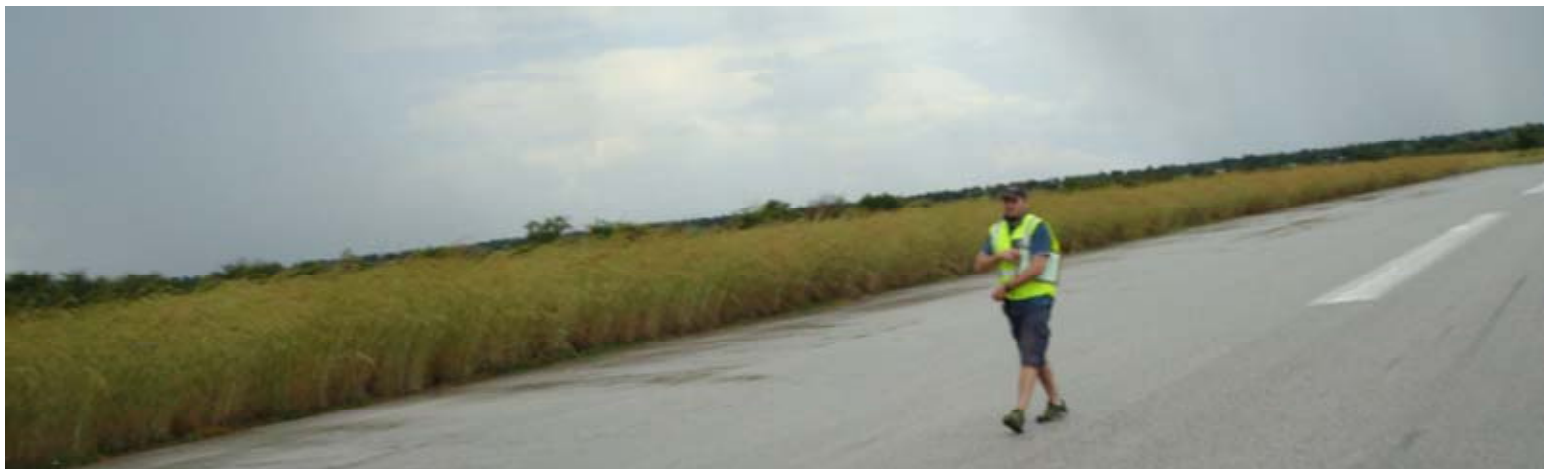
**RA 9: Height of uncut grass on the shoulder edge.**

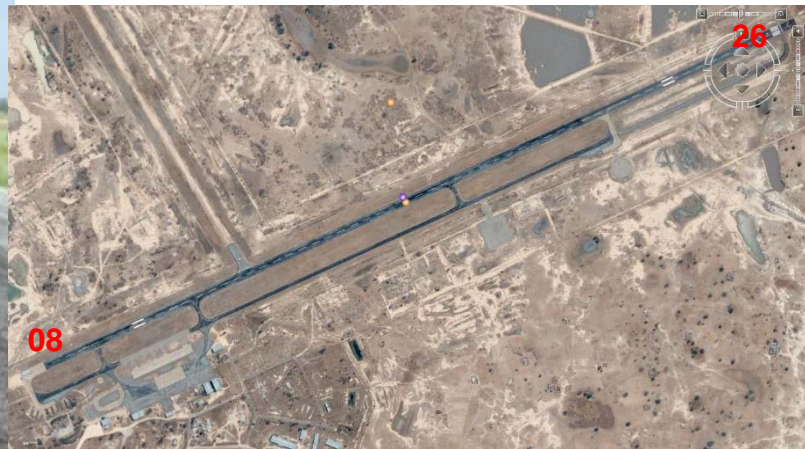
**OA 14: Loose geo-fabric at 2007 crack sealing on shoulder. Extent of previous crack sealing and aged surface can also be seen.**

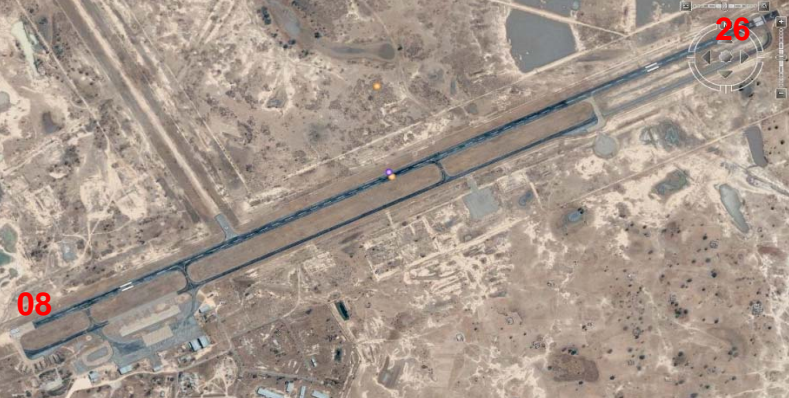
**OA 22: Badly potholed and ravelling area A linking newly constructed refuel apron with area in front of large hangers. V type drain functioning in foreground.**

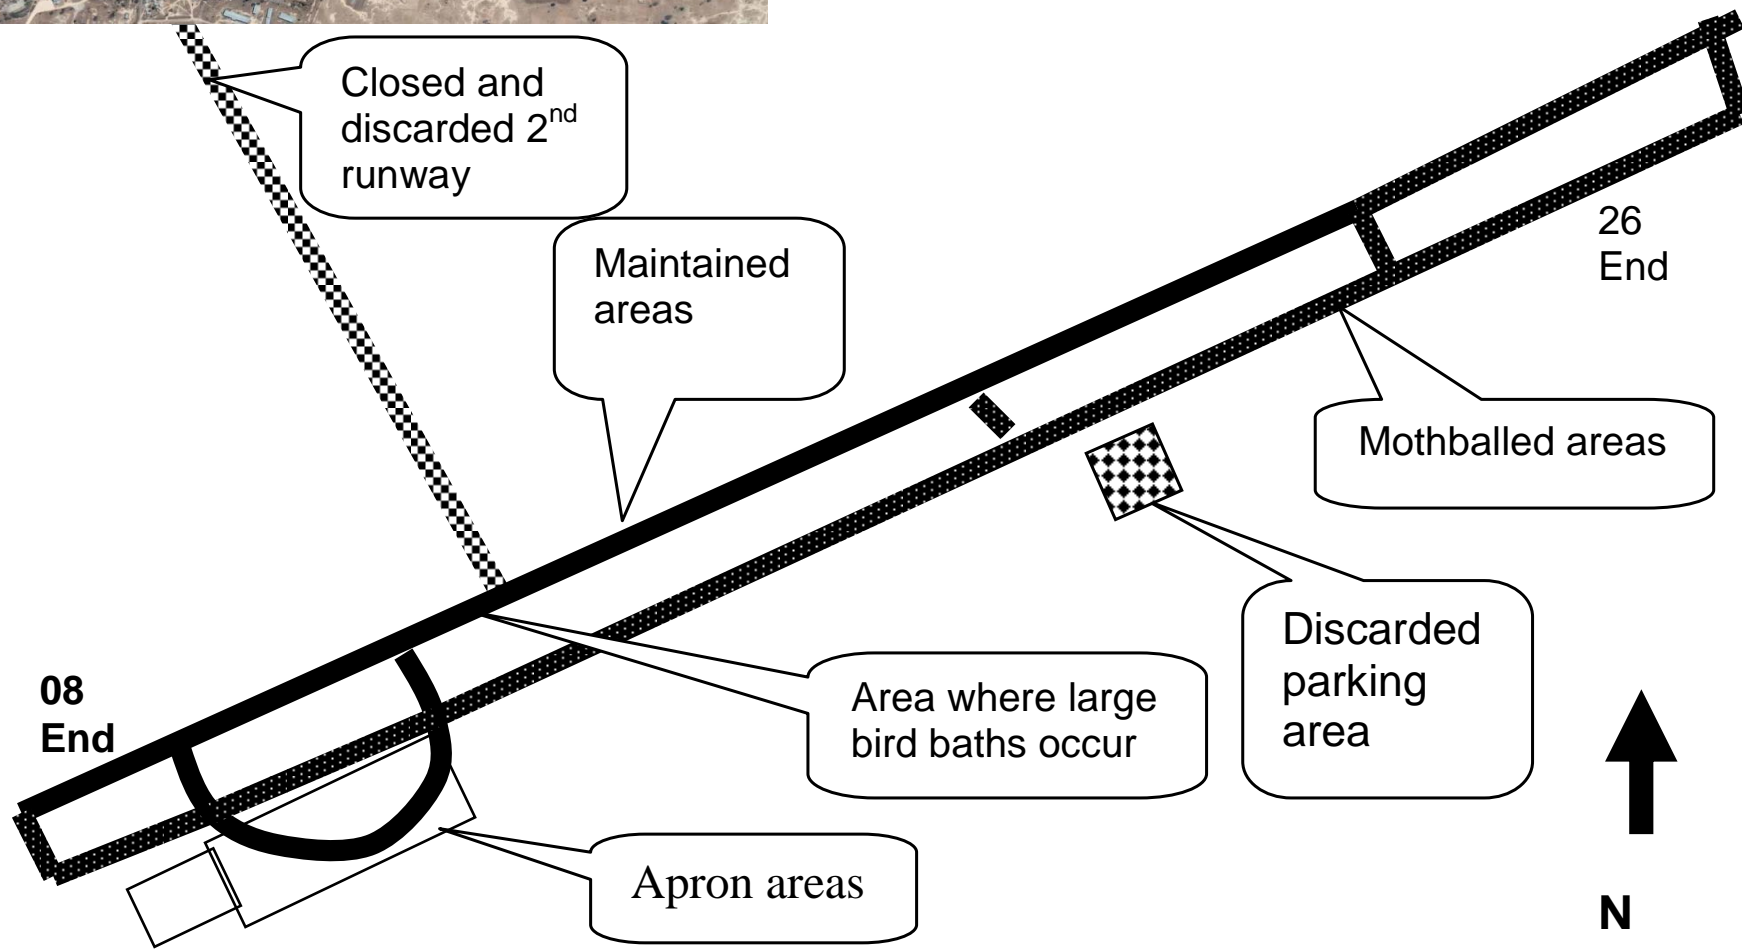
Sketch plan layout of Ondangwa airport

Airport	Condition rating
Ondangwa	Severe

- Limited crack seal runway, taxiway lane and apron
- Urgently follow up with new bitumen rubber seal on runway.
- Rejuvenator spray on reduced taxiway lanes and apron areas.

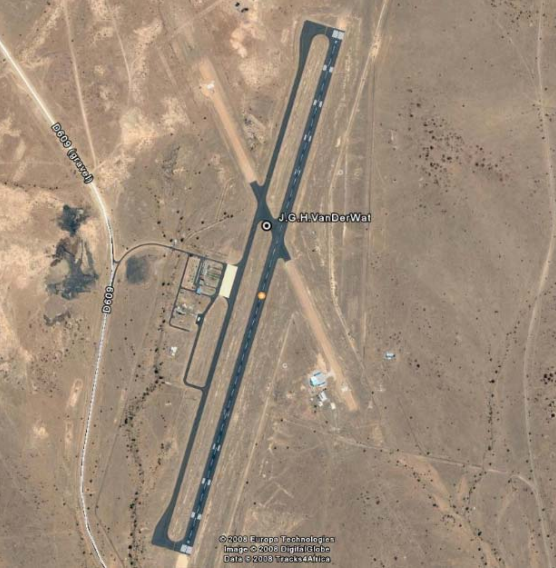
**3: Longitudinal cracking and localised repair on shoulder.**

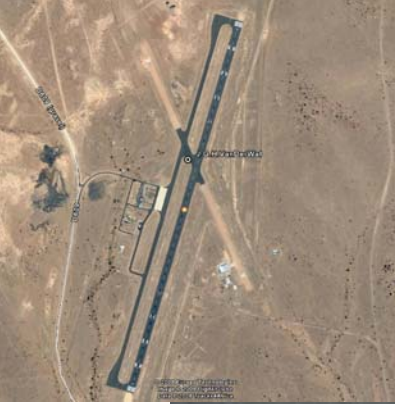
**KA 6: Longitudinal cracking with vegetation in old construction joint on shoulder of main runway.**

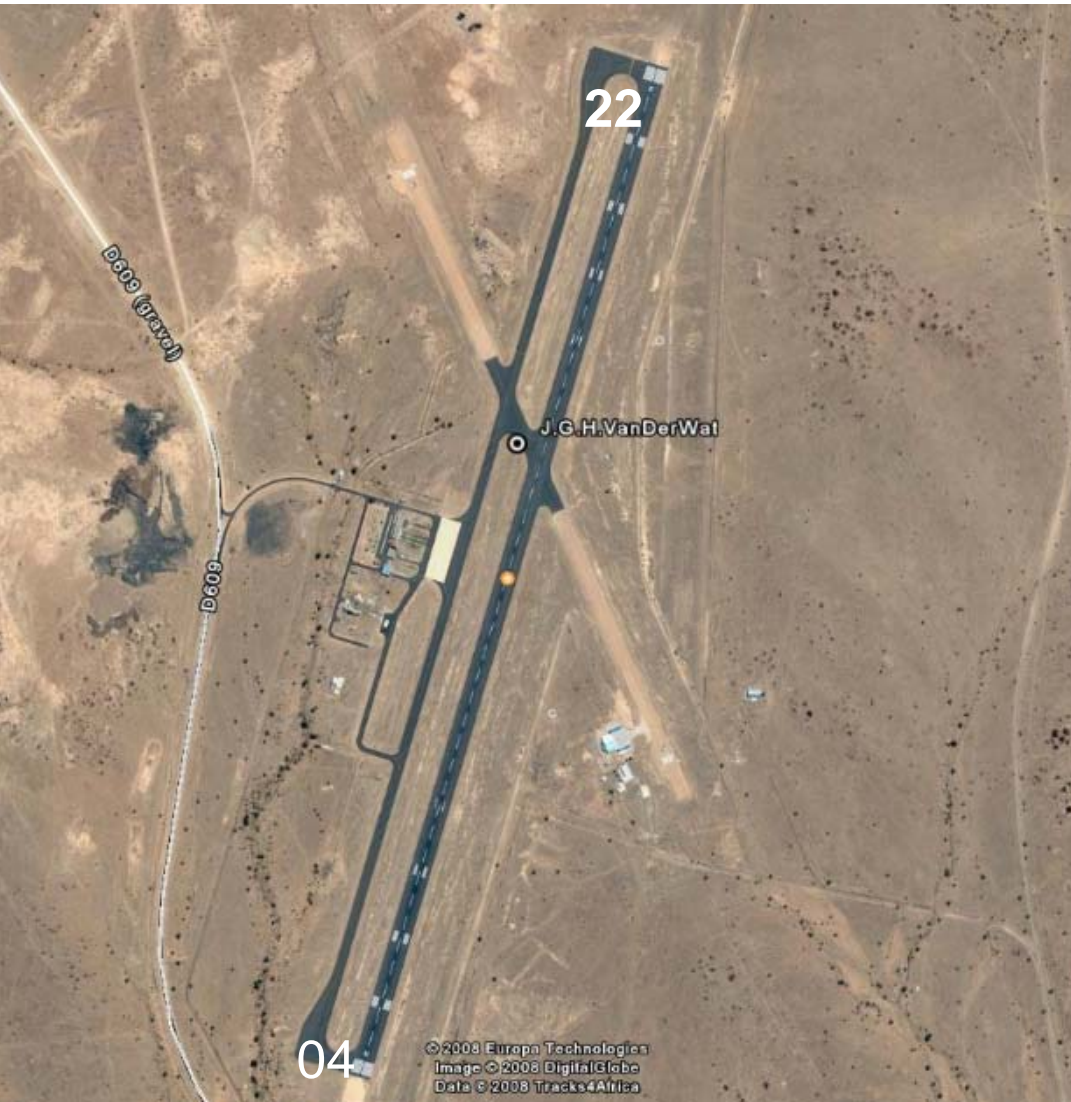
Airport	Condition rating
Keetmanshoop	Sound to warning

Reduce runway width from 45m to 30m with paved shoulders. Mothball large holding areas at thresholds on taxiway.

Crack filling of longitudinal cracks, minor patching and rejuvenation in medium term.
